STORMWATER INSPECTION REPORT

The Edison at Peytona Downs

1137 GreenLea Blvd, Gallatin, TN, 37066

DATE: 06/26/2024

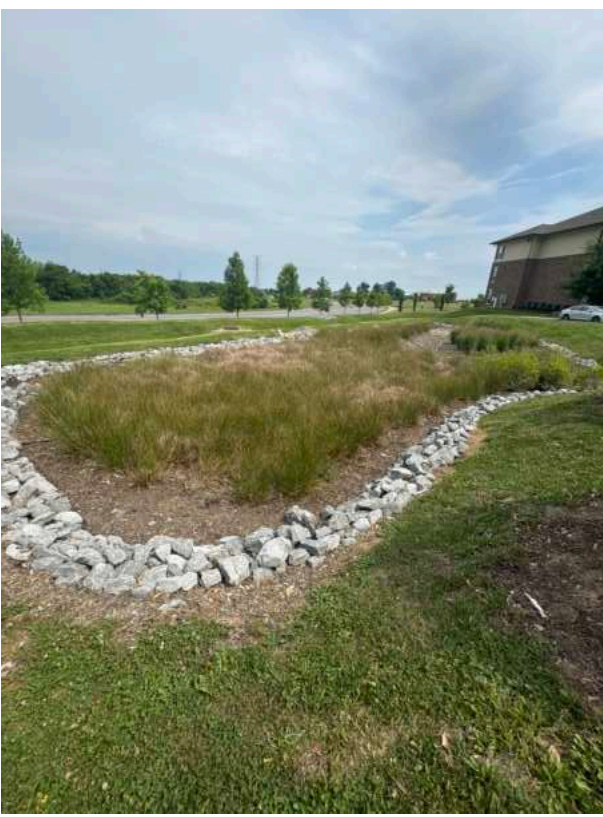
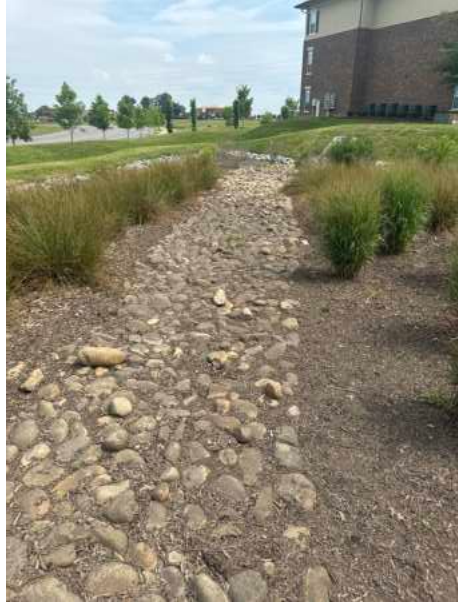
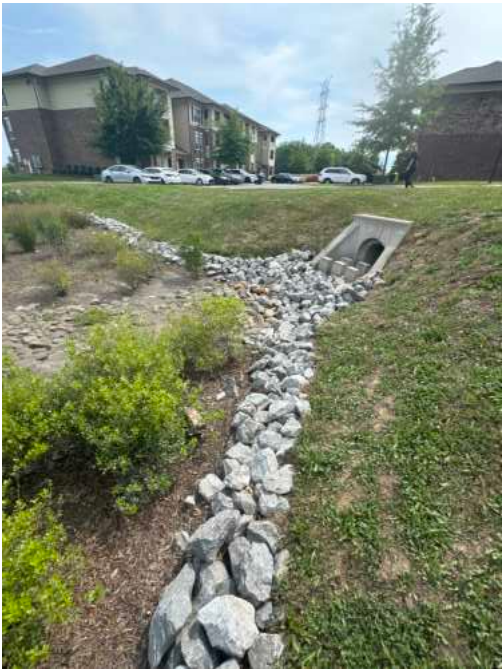
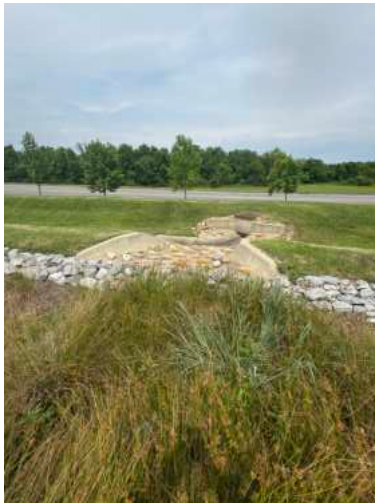
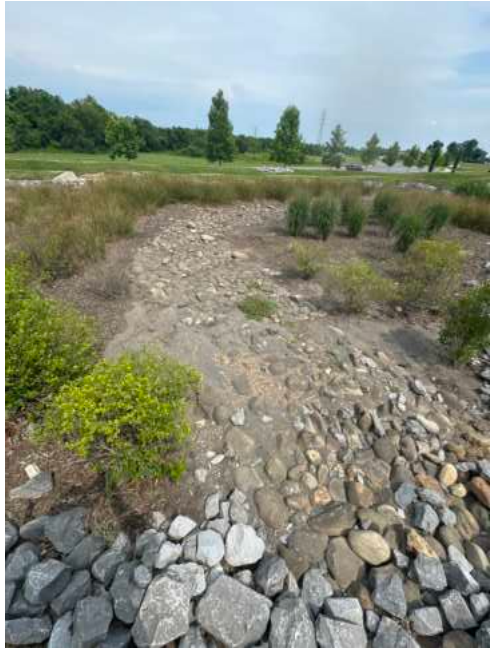
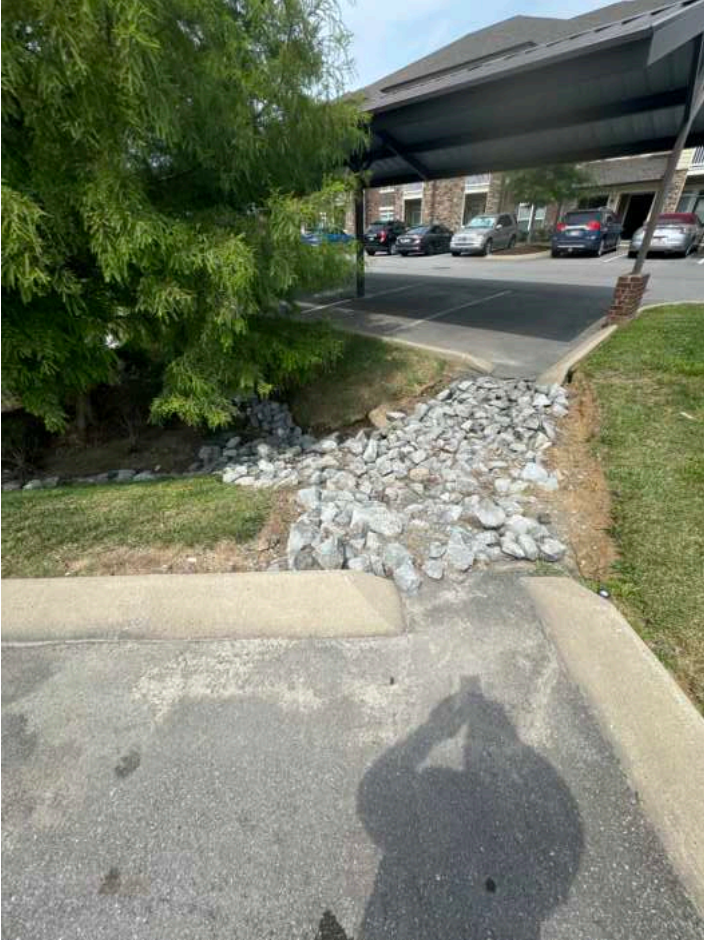
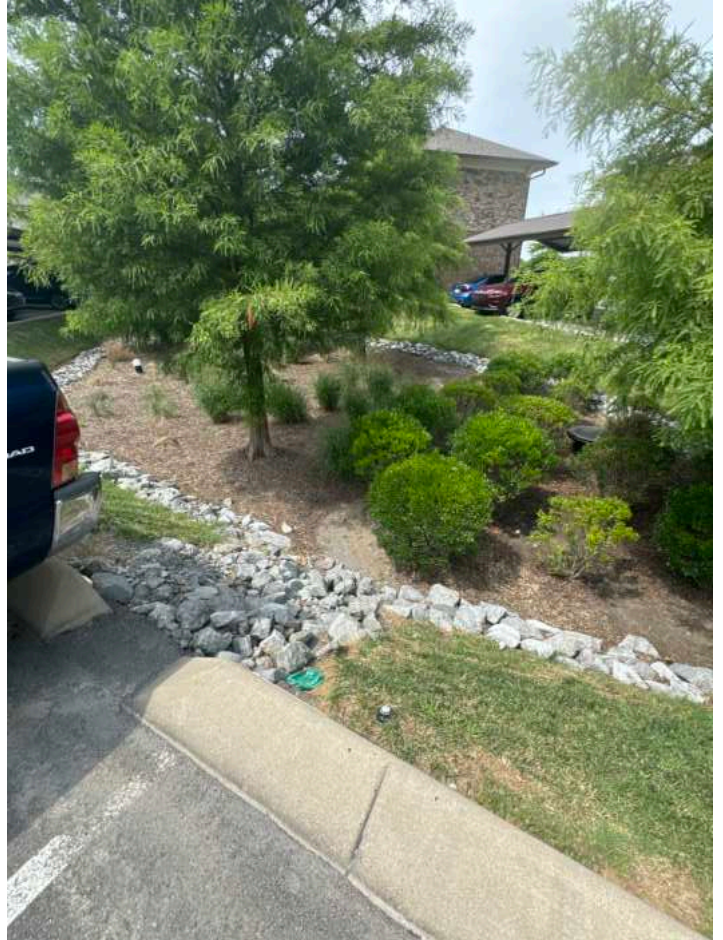
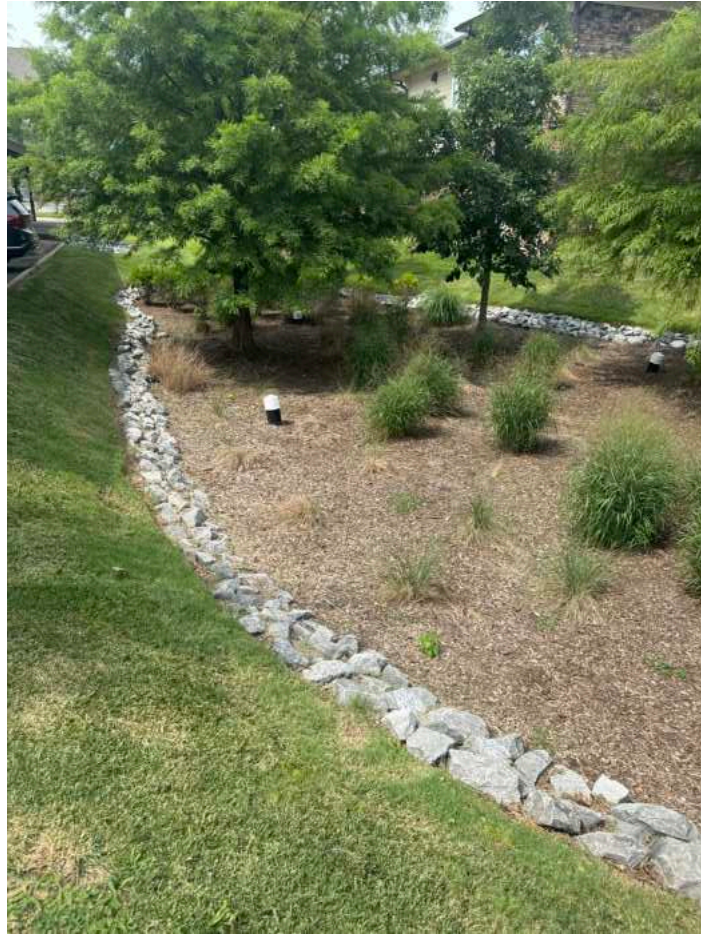
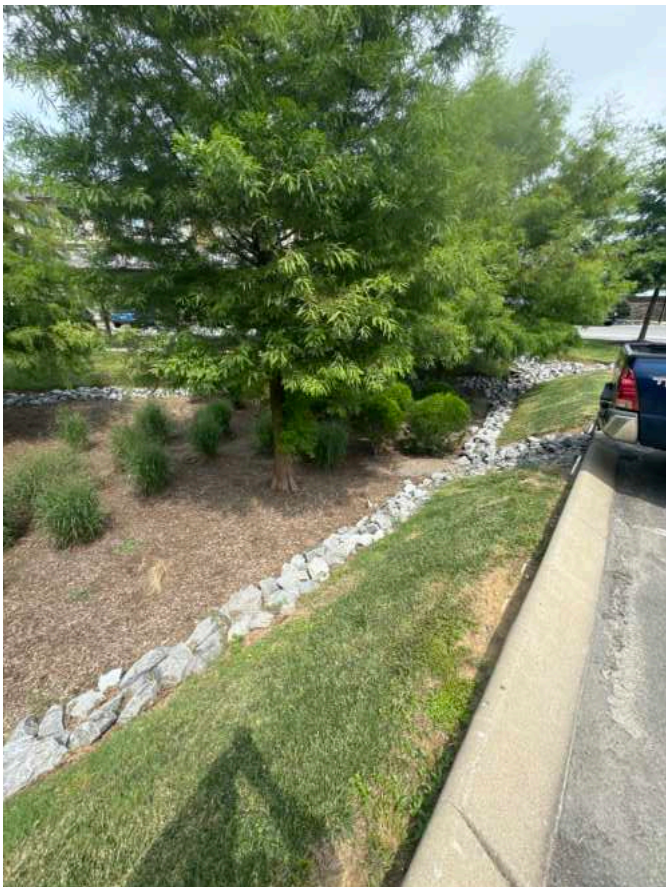
Bioretention Pond #2

Additional Notes:
 EverGreen inspected Bio Pond #2 at the Edison on June 26th, 2024. Upon inspection no problems or issues were identified. The pond is in great health, from the vegetation to the mulch. No maintenance is necessary. EverGreen will continue to monitor and advise.

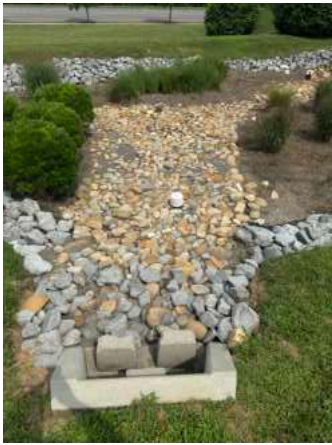
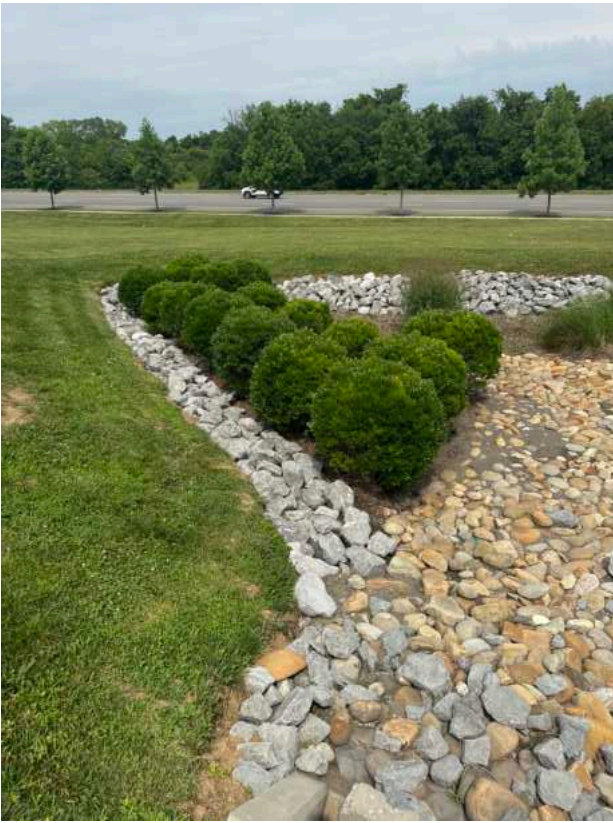
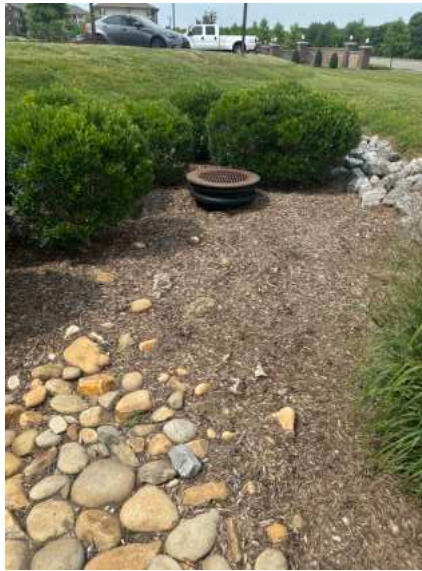
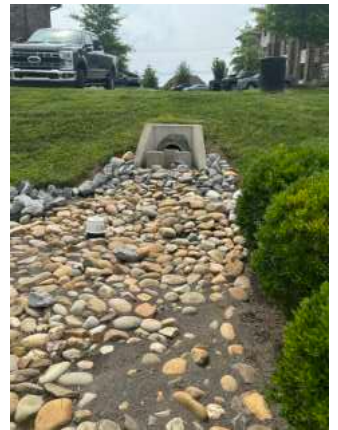
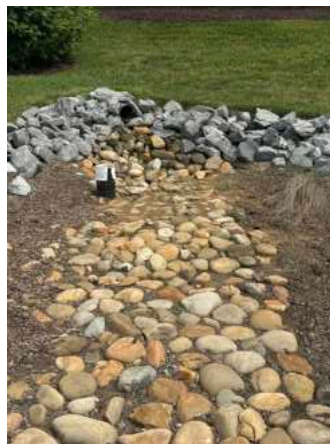
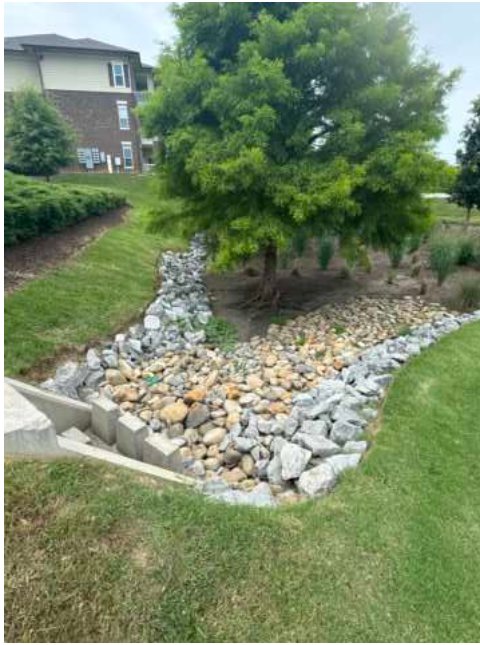
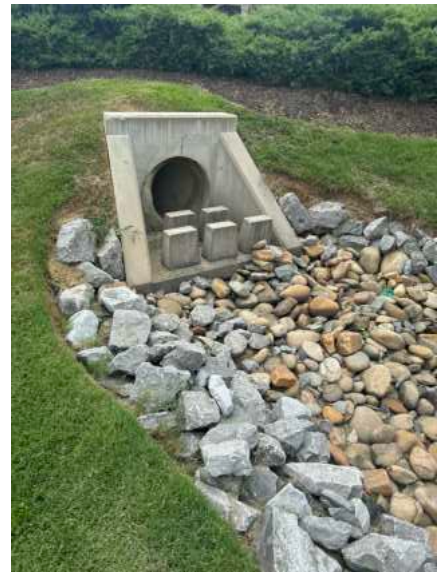
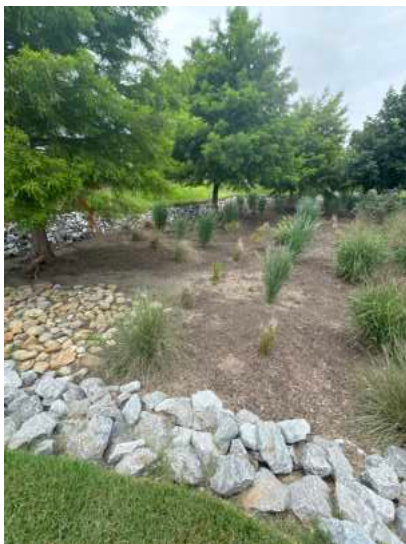
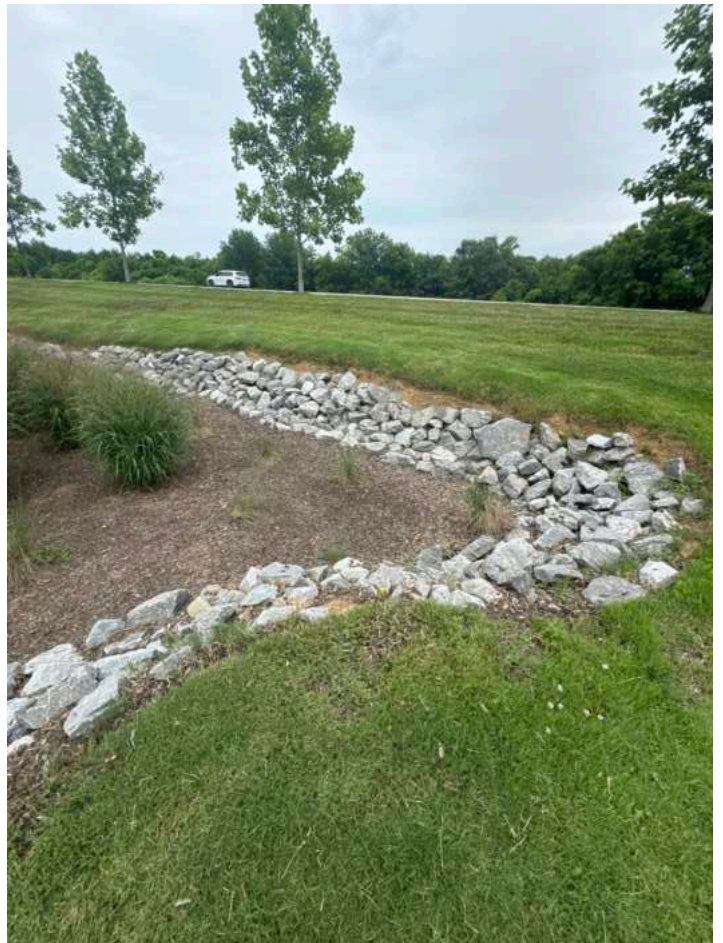
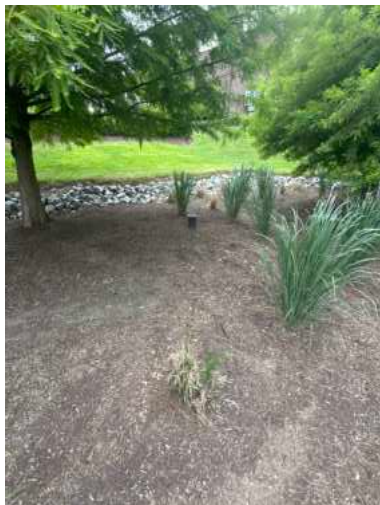
Bioretention Pond #3

Additional Notes:
 EverGreen inspected Bio Pond #3 at the Edison on June 26th, 2024. During the inspection of Bio pond #3, sediment accumulation was observed specifically in one area by some of the stones. However, it was determined that no maintenance is necessary for this particular issue. EverGreen will continue to monitor and advise.

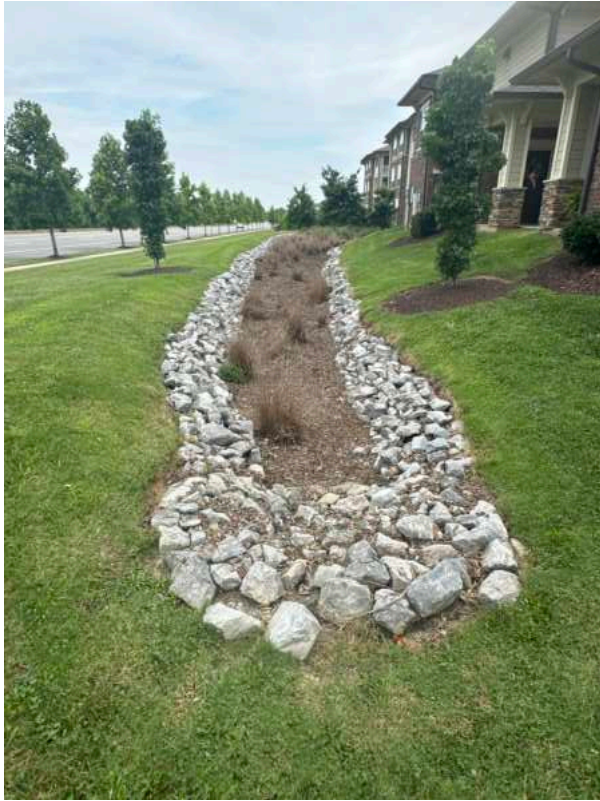
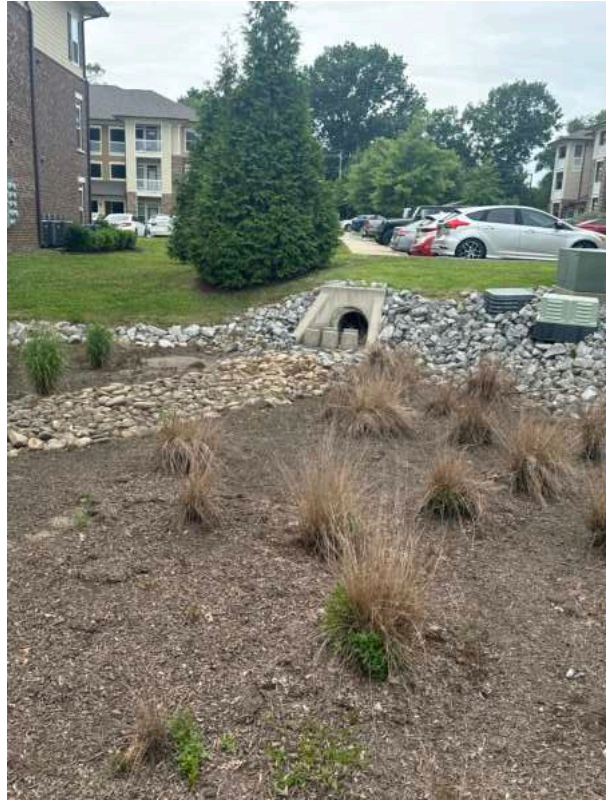
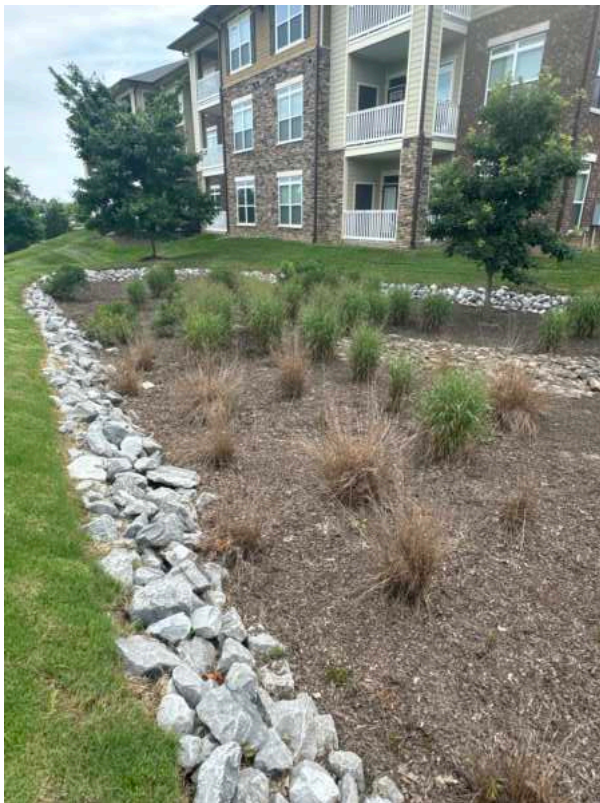
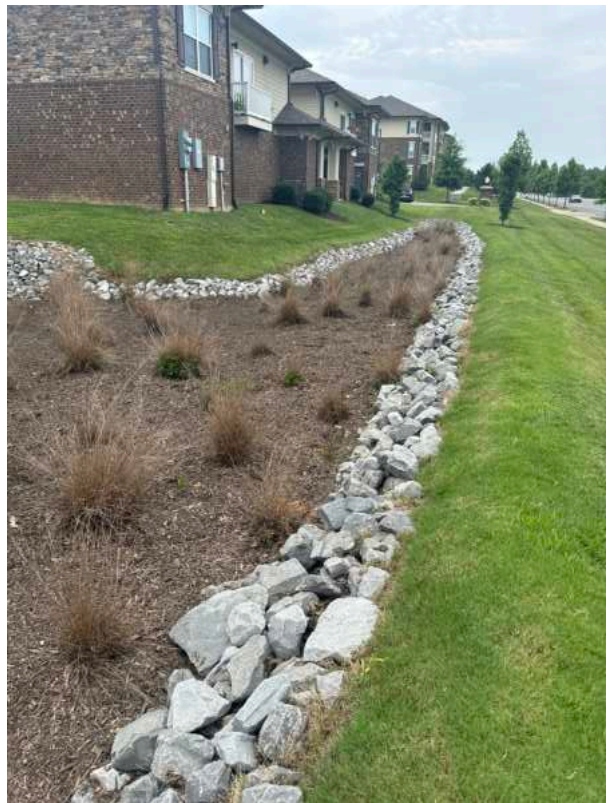
Bioretention Pond #4

Additional Notes:
 EverGreen inspected Bio Pond #4 at the Edison on June 26th, 2024. Bio Pond #4 was inspected and found to be in perfect health, functioning optimally. No issues or problems were observed during the inspection, indicating that the pond is operating as intended and requires no maintenance or corrective actions.

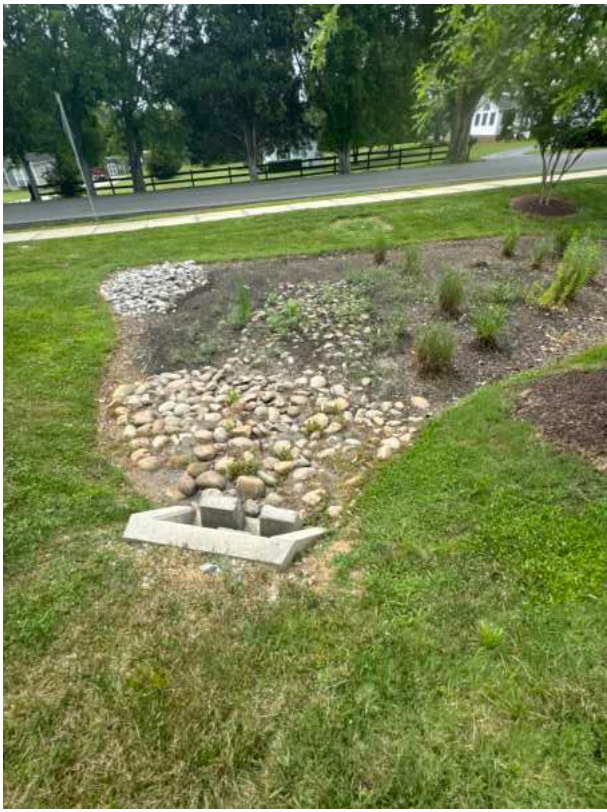
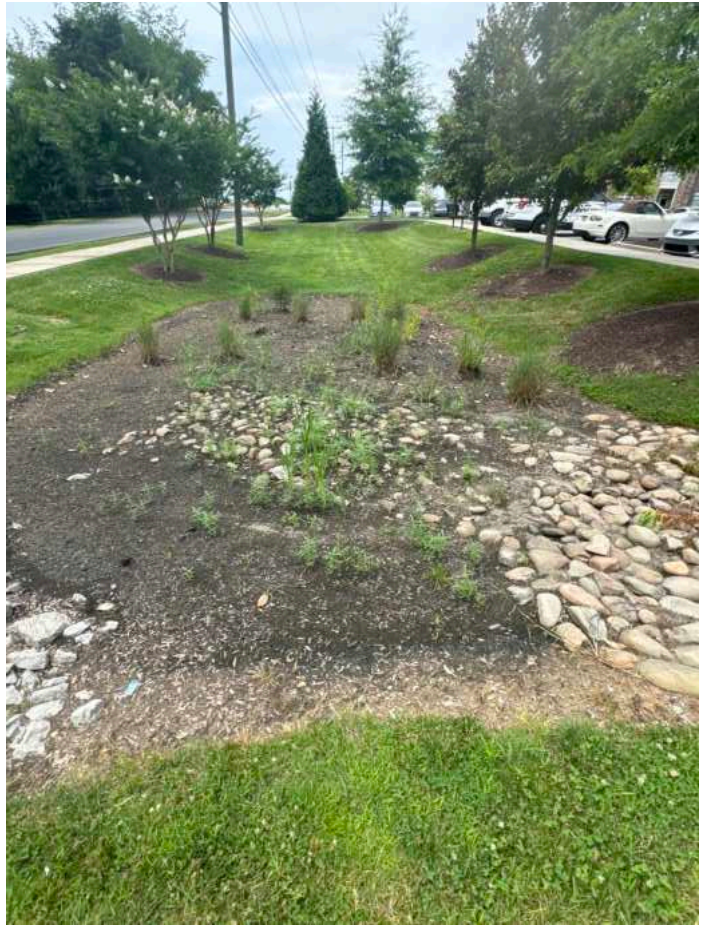
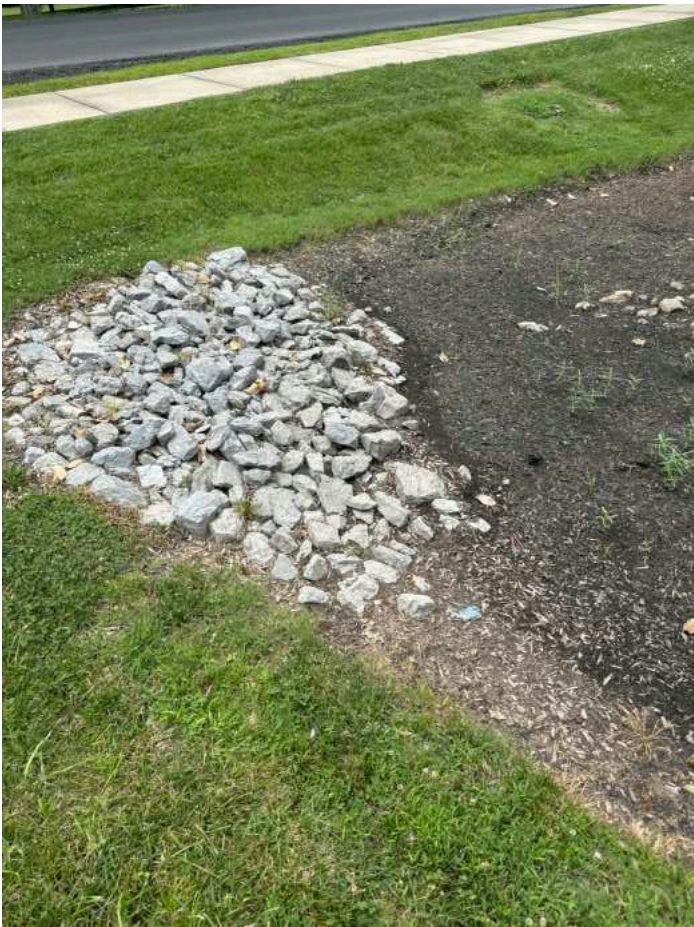
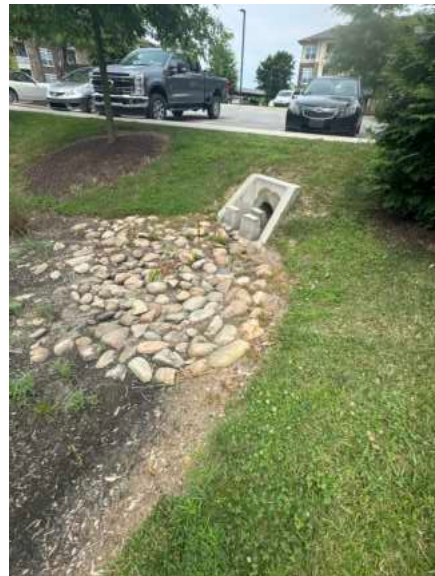
Bioretention Pond #6

Additional Notes:
 EverGreen inspected Bio Pond #6 at the Edison on June 26th, 2024. Bio Pond #6 was thoroughly examined and determined to be in perfect condition, operating at peak performance. The inspection revealed no issues or deficiencies, indicating that the pond is functioning optimally and does not require any maintenance or corrective actions at present.

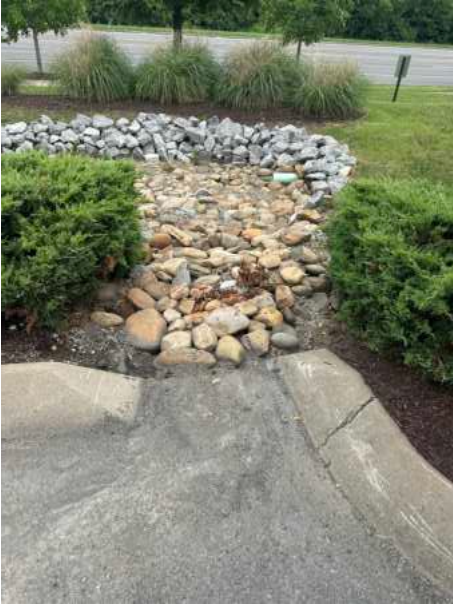
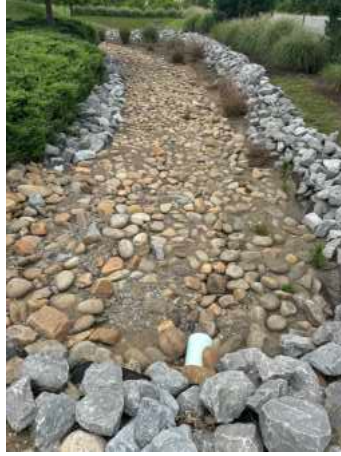
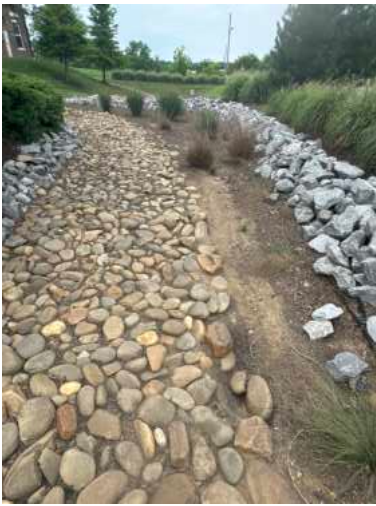
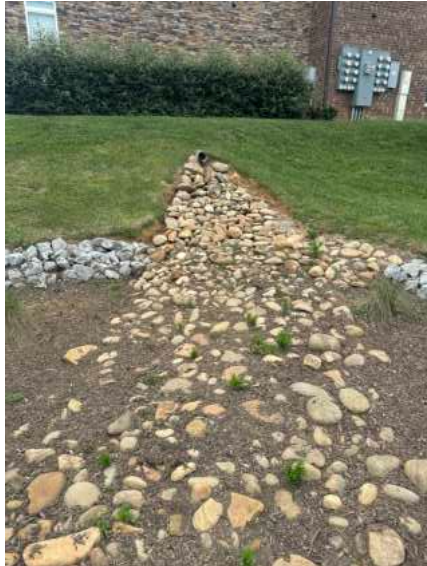
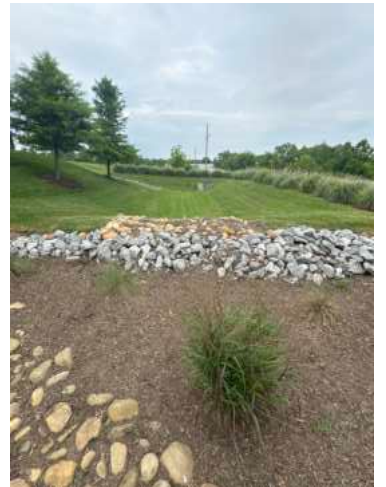
Bioretention Pond #7

Additional Notes:
EverGreen inspected Bio Pond #7 at the Edison on June 26th, 2024. Bio Pond #7 underwent a comprehensive inspection, which revealed that the pond is generally in good condition. However, a light accumulation of sediment was observed within the pond. While this sediment accumulation is minimal and does not pose a significant concern at this time, it is recommended to monitor the situation and consider periodic maintenance to prevent any potential issues in the future.

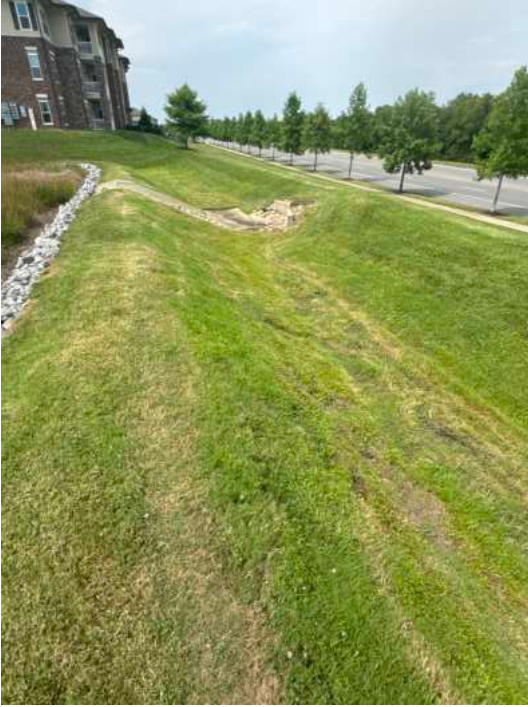
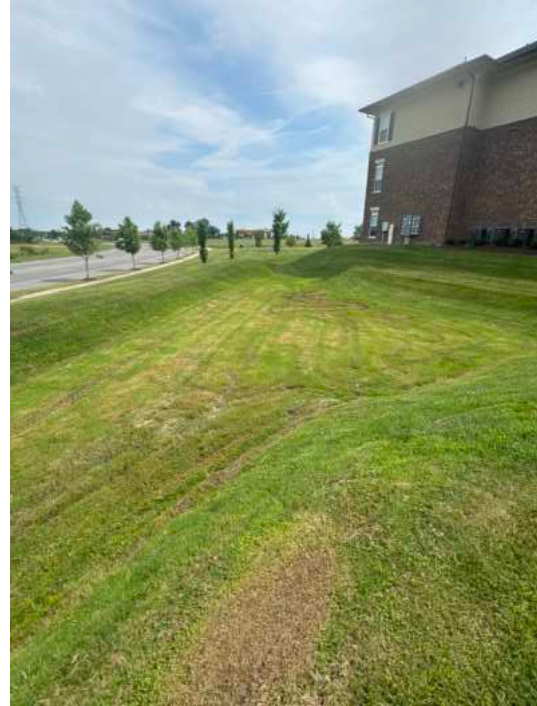
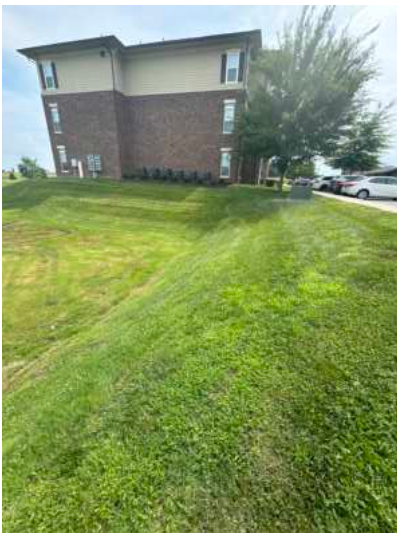
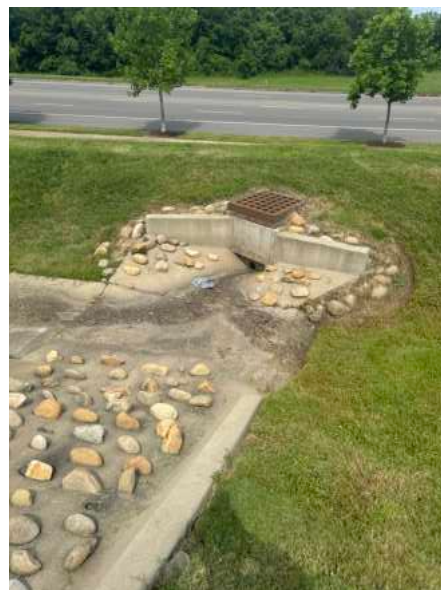
Bioretention Pond #8

Additional Notes:
 EverGreen inspected Bio Pond #8 at the Edison on June 26th, 2024. Bio Pond #8 was thoroughly inspected and found to be in excellent overall health. The pond is functioning optimally and does not require any immediate maintenance or corrective actions. However, during the inspection, it was noted that there was a small amount of trash present in the pond. Although this trash does not pose a significant threat to the pond's functionality or ecosystem, it is recommended to periodically remove the trash to maintain the aesthetic appeal and cleanliness of the pond.

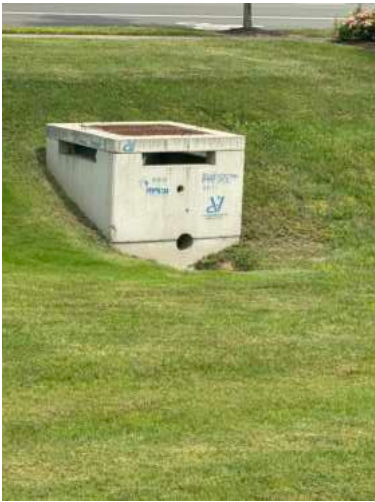
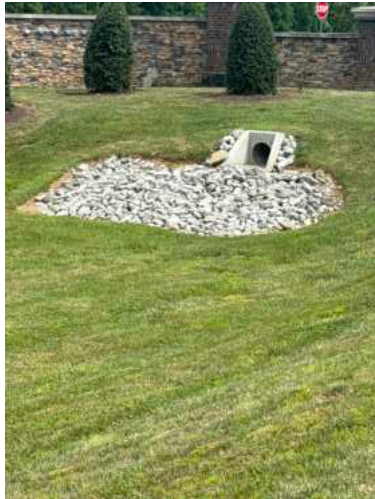
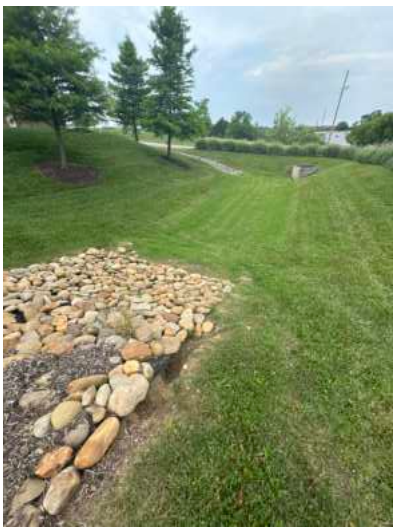
Additional Notes:
EverGreen inspected Dry Pond #2 at the Edison on June 26th, 2024. Detention Pond #2 was thoroughly inspected and found to be in excellent health. No issues or problems were observed during the inspection. The pond is functioning as intended and does not require any immediate maintenance or corrective actions. It is important to continue monitoring the pond regularly to ensure its continued good health and functionality.
