STORMWATER MAINTENANCE REPORT

EverGreen Site Solutions

Facility: Lenox Village Town Center - Pond #3 (Pond C) File No: 2005-273

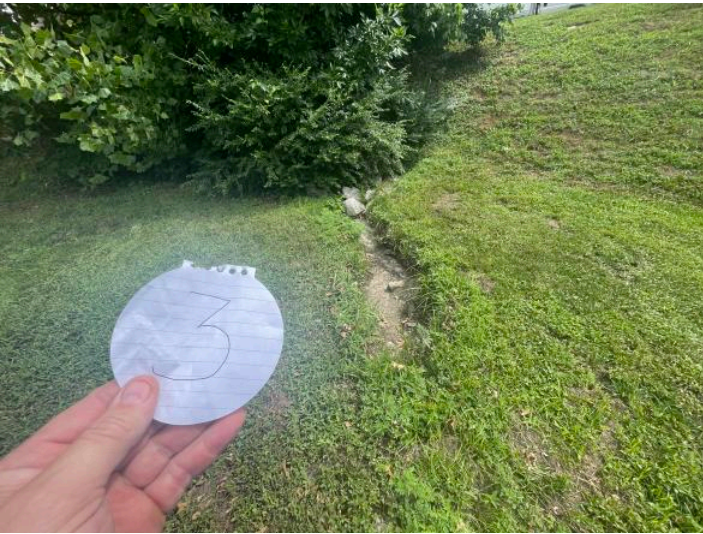
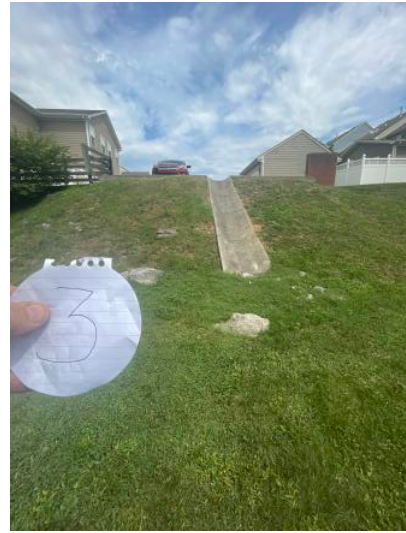
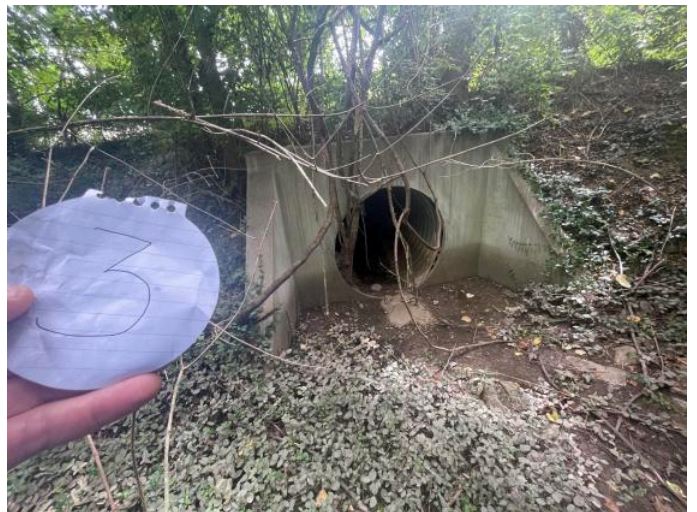
Detention Pond #3 (C)

Before

Additional Notes:
 EverGreen performed maintenance at Lenox Village Town Center following a NOV from Metro Stormwater. At Pond #3 (Pond C), EverGreen removed all vegetation from all three (3) inlets and outlet to a radius of 20', put down to a radius of 10' a layer of geotextile fabric to prevent future growth, and topped geotextile fabric with large angular rip rap. Everything is functioning as required and no new maintenance is currently needed.

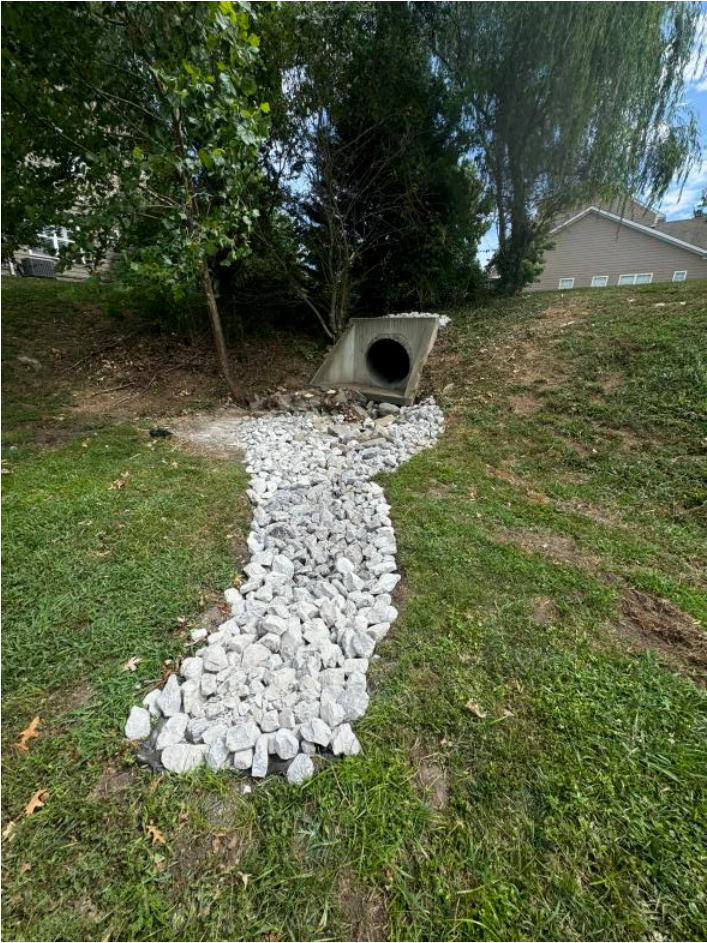
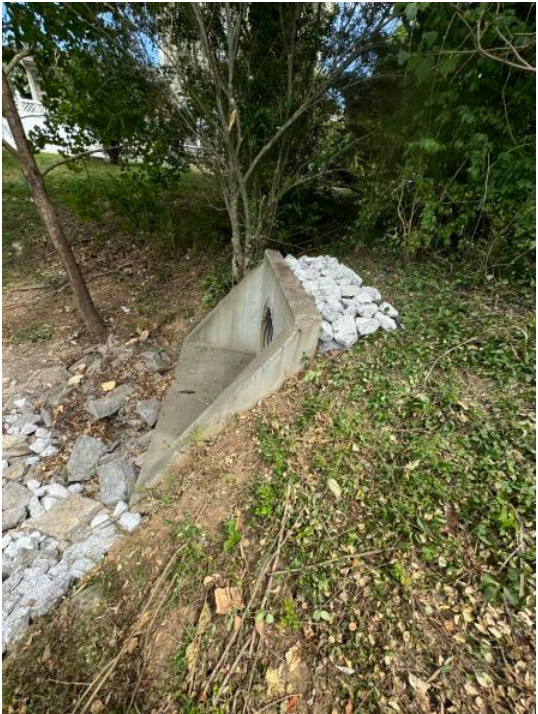
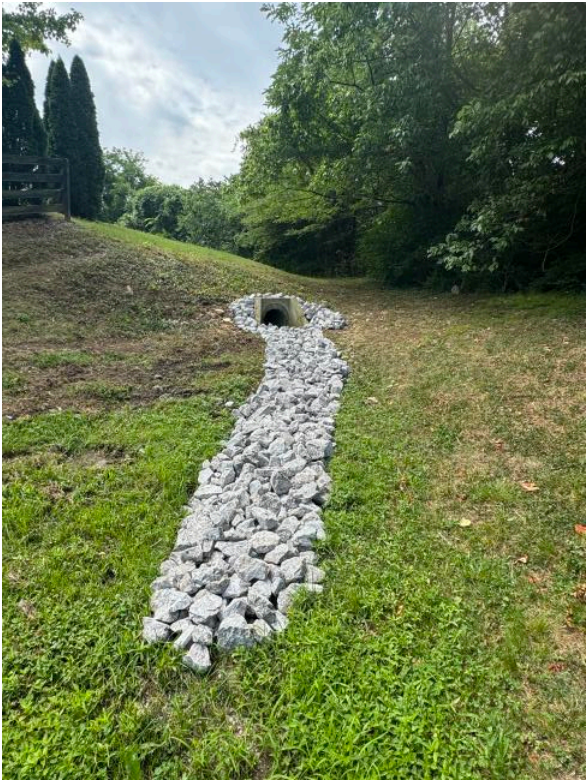
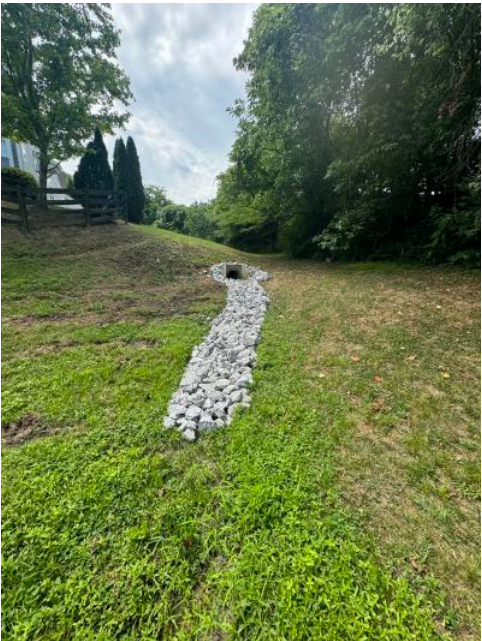
Detention Pond #3 (C)

After

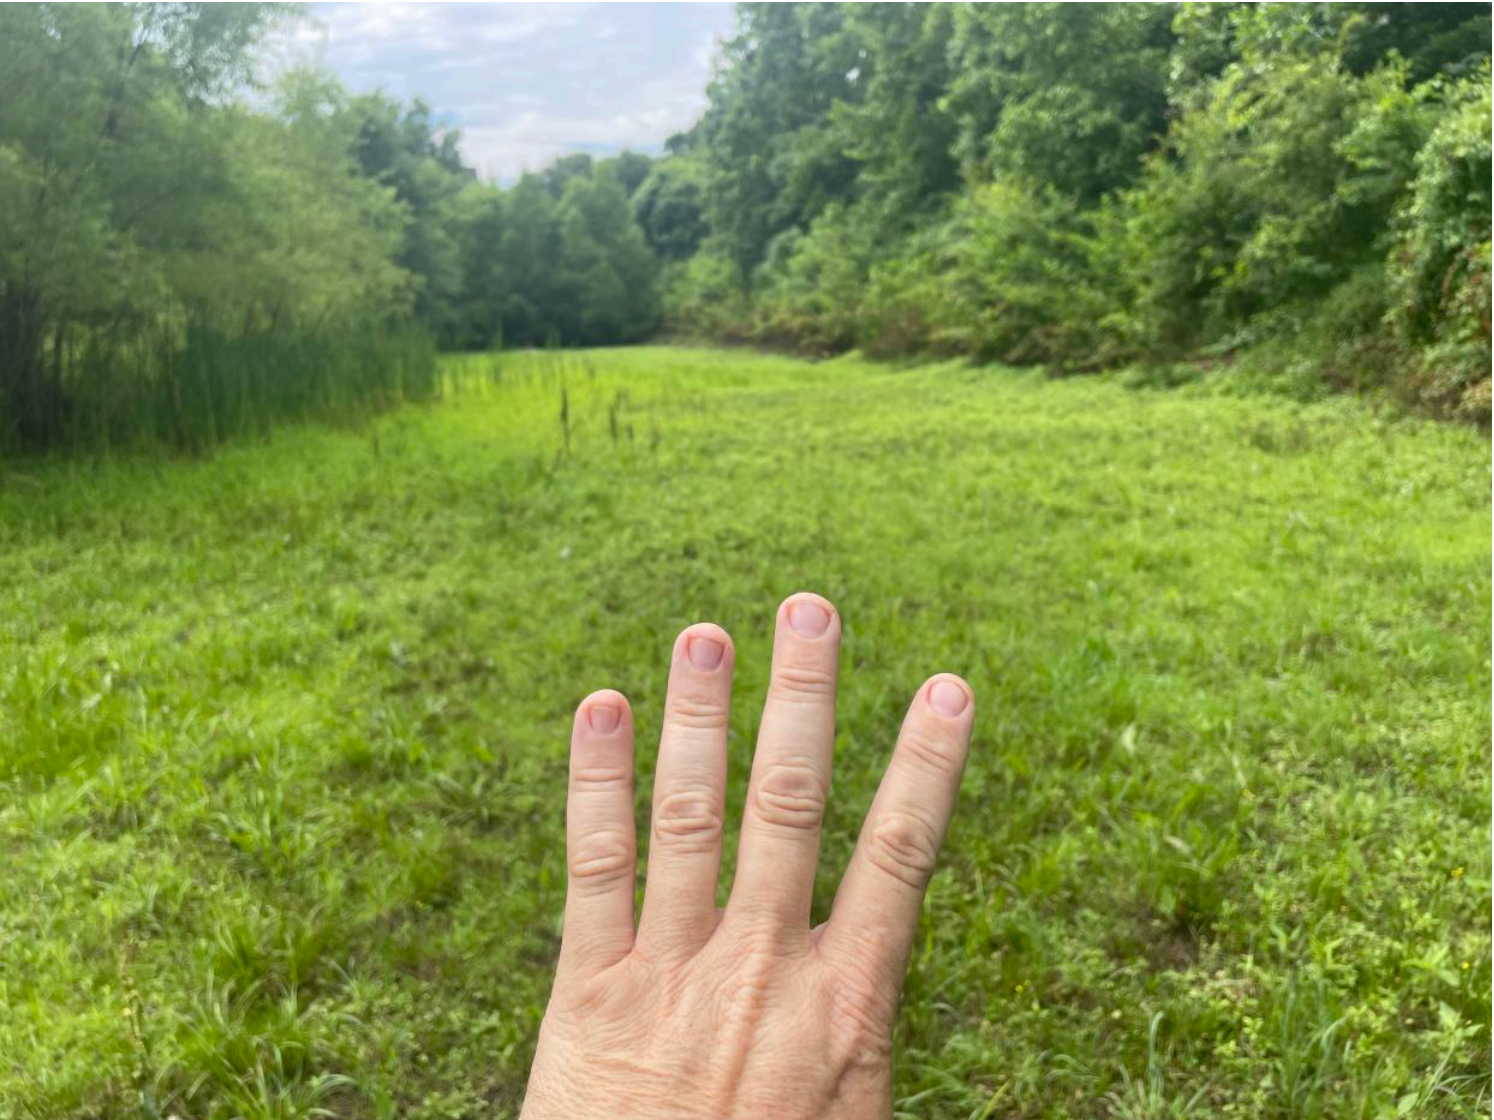
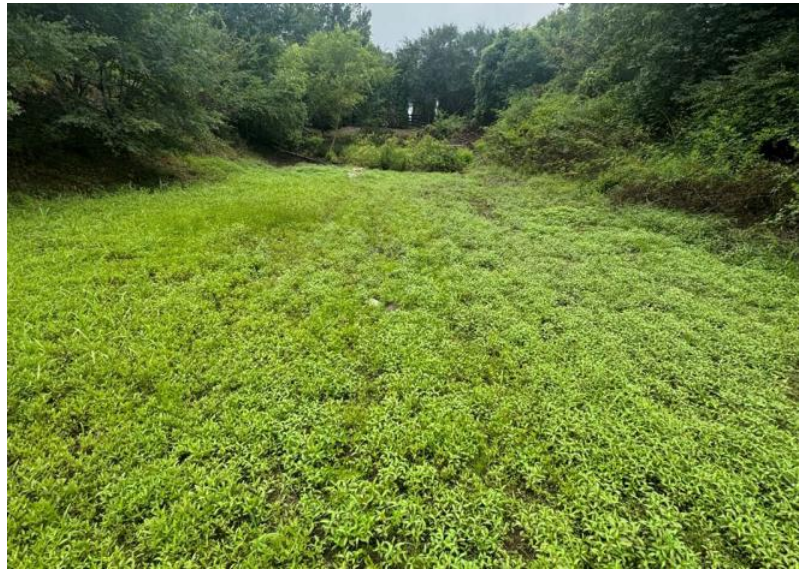
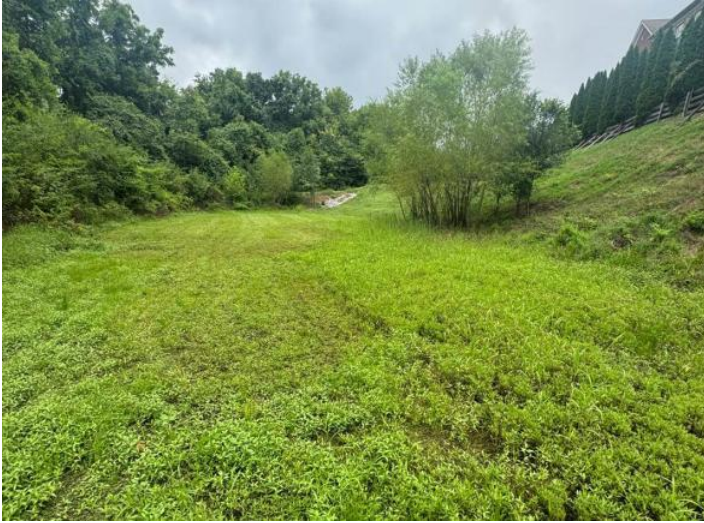
Detention Pond #4 (B)

Before

Additional Notes:
 EverGreen performed maintenance at Lenox Village Town Center following a NOV from Metro Stormwater. At Pond #4 (Pond B), EverGreen removed all vegetation from all three (3) inlets and outlet to a radius of 20', put down to a radius of 10' a layer of geotextile fabric to prevent future growth, and topped geotextile fabric with large angular rip rap. Everything is functioning as required and no new maintenance is currently needed.

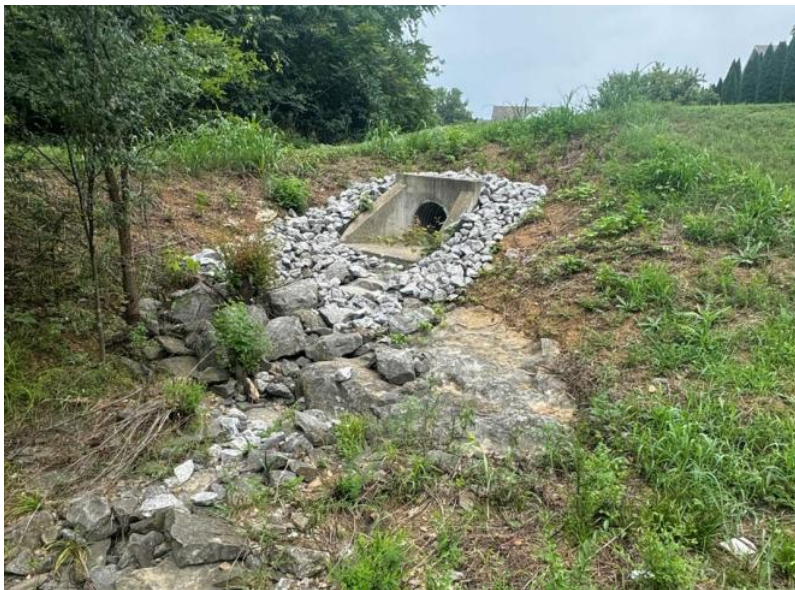
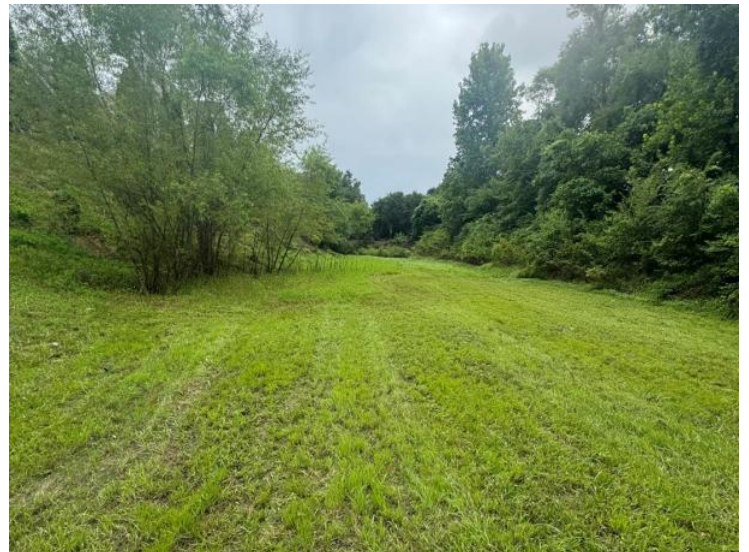
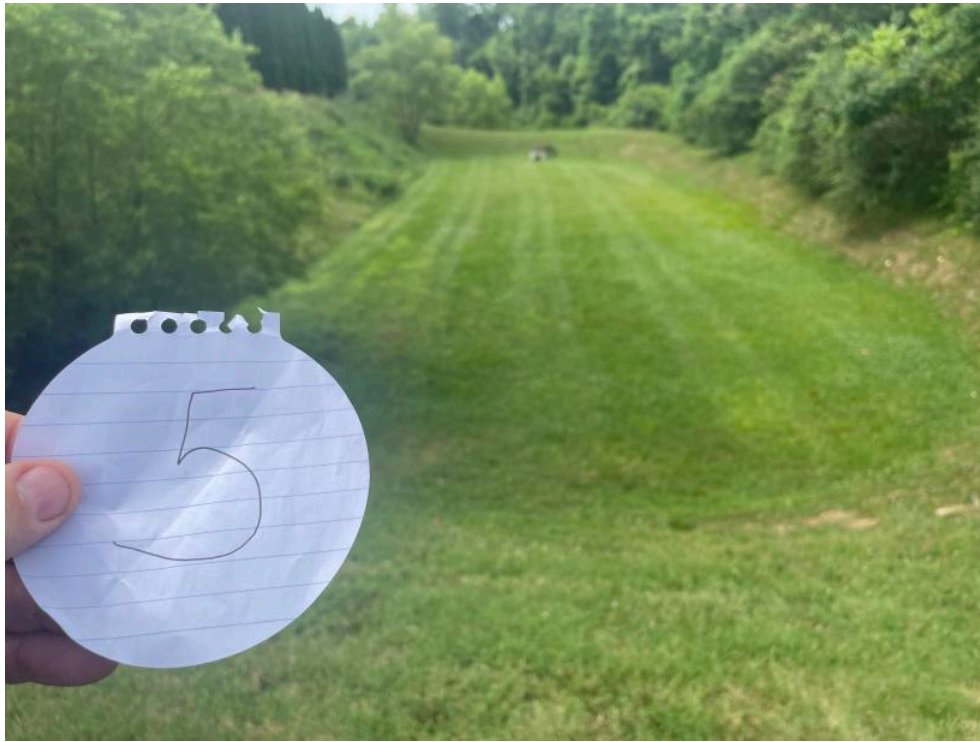
Detention Pond #4 (B)

After

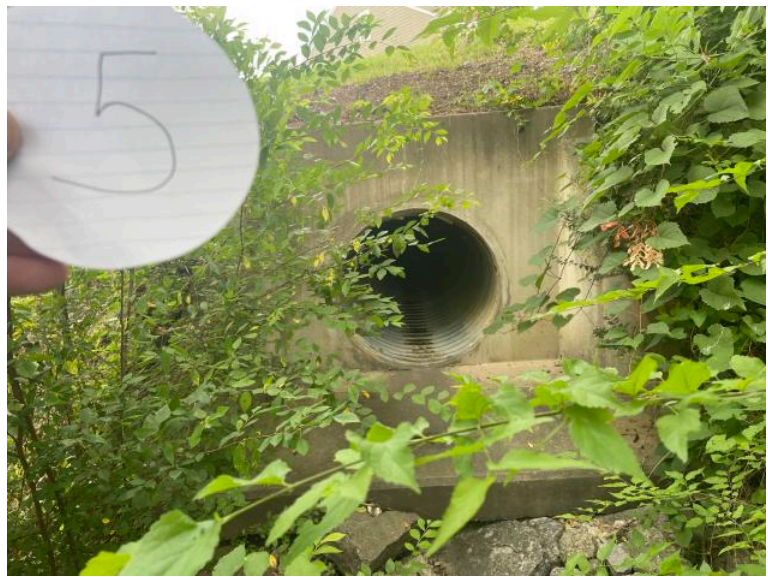
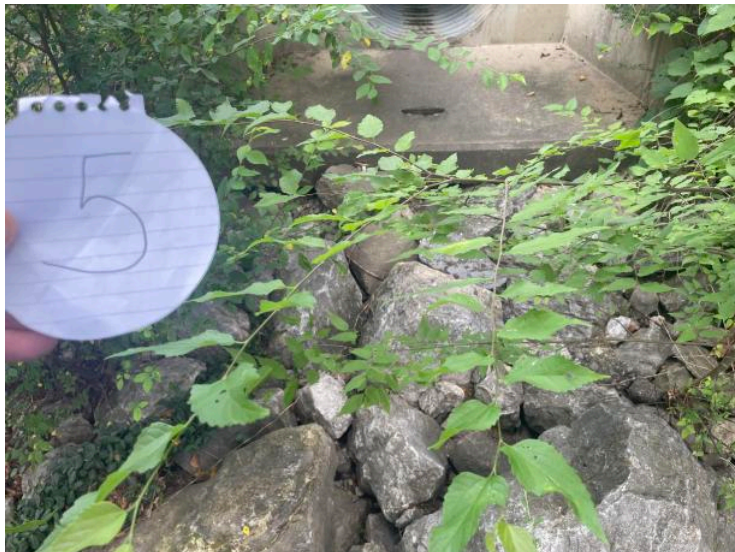
Detention Pond #5 (A)

Before

Additional Notes:
EverGreen performed maintenance at Lenox Village Town Center following a NOV from Metro Stormwater. At Pond #5 (Pond A), EverGreen removed all vegetation from all three (3) inlets and outlet to a radius of 20', put down to a radius of 10' a layer of geotextile fabric to prevent future growth, and topped geotextile fabric with large angular rip rap. Everything is functioning as required and no new maintenance is currently needed.

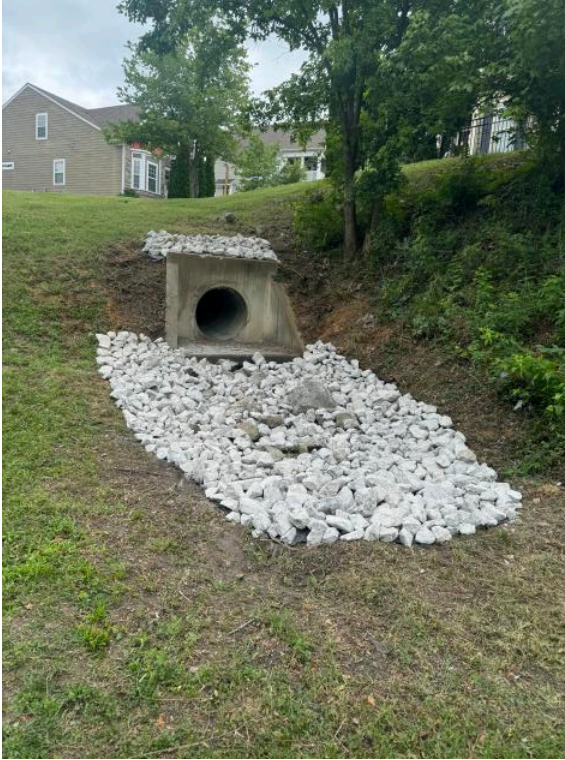
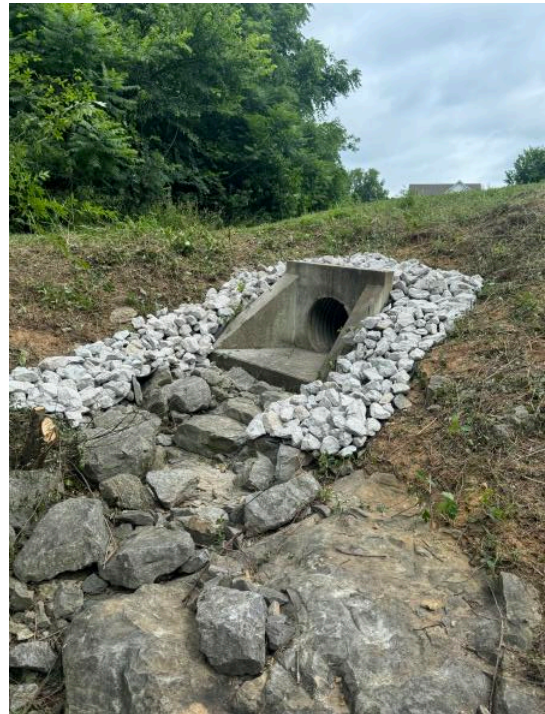
Detention Pond #5 (A)

After

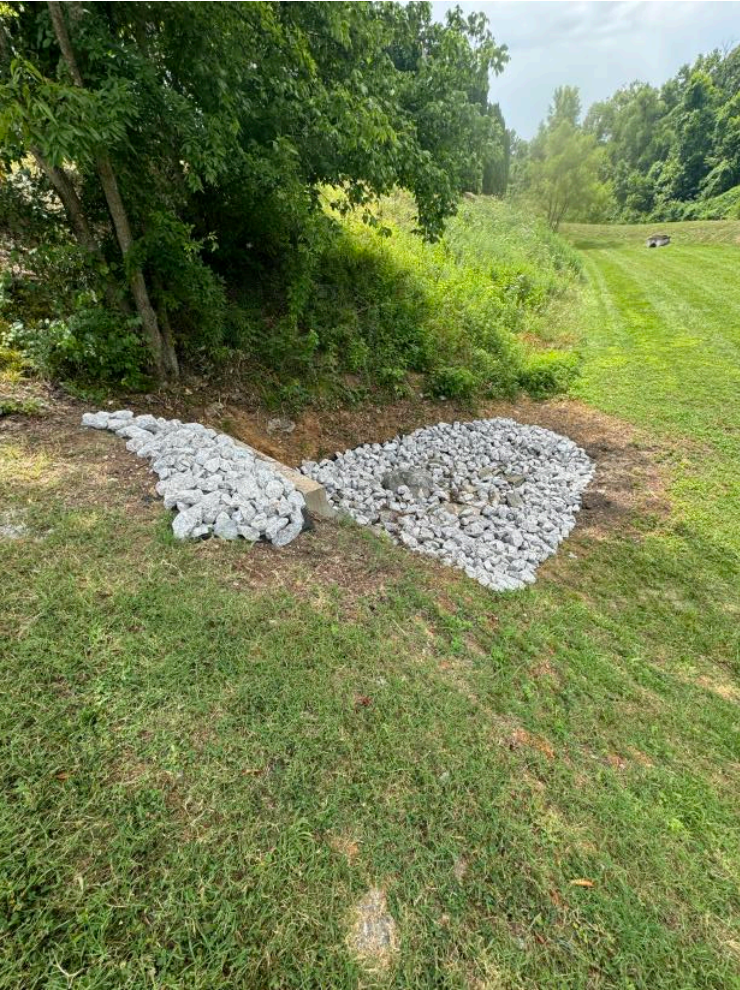
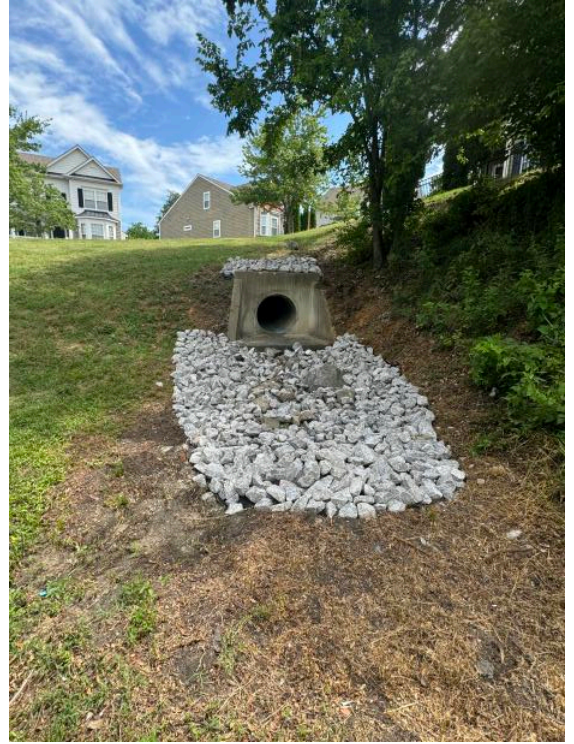
Detention Pond #5 (A)

After
