# STORMWATER MAINTENANCE REPORT

5095 Murfreesboro Rd is a commercial construction site. The facility under construction by Sunbelt Construction company. The primary parcel that contains green infrastructure practices (GIP) is Parcel #015-002.12-000. The parcel contains 1.63 acres with a relative mix of pervious and impervious surfaces.

The green infrastructure practice that is employed on the site is permeable pavers. The illustration below shows an overhead view of the facility. The pavers that maintenance was done on are labeled appropriately.

**MAINTENANCE PICTURES**

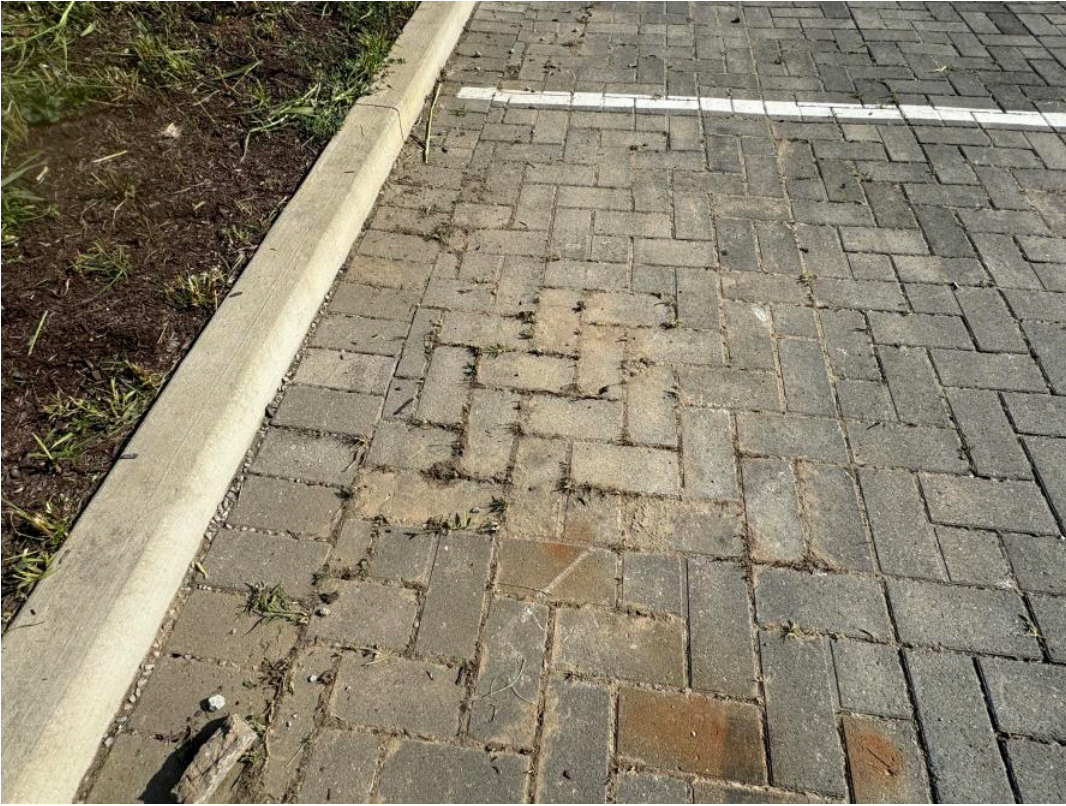
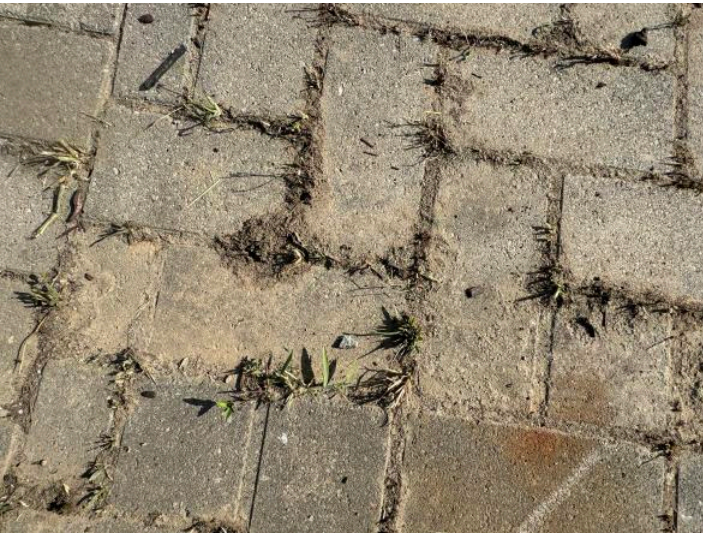
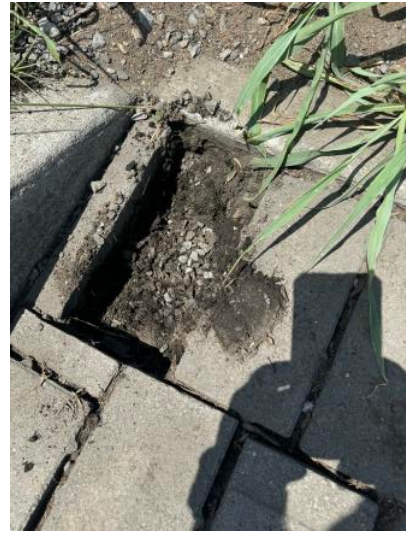
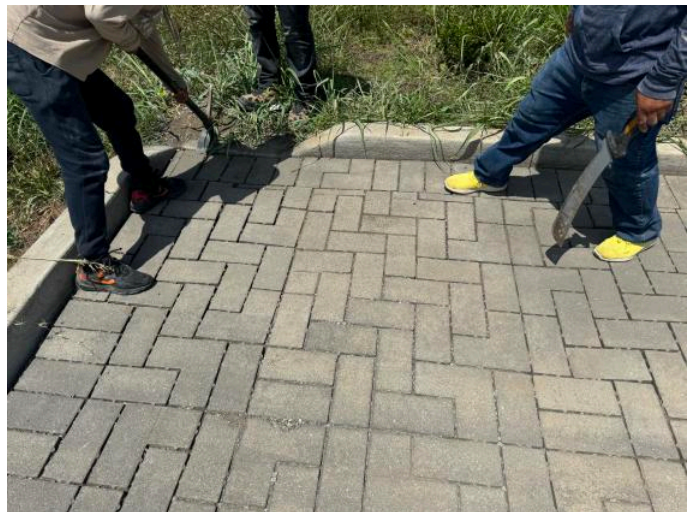
Pavers

Before

Additional Notes:  
 EverGreen performed maintenance at at 5095 Murfreesboro Rd. The location had three areas of permeable blocks that were not functioning correctly. EverGreen started by performing routine maintenance of the pavers such as using an air sweeper truck to remove debris. After further testing, it was determined that a the back 3 feet of the parking lot was so bad that a reconstruction in those areas was necessary. EverGreen removed the pavers in place, tested the layer underneath to determine infiltration, removed the open graded stone to a depth of 1.5 feet, and then reconstructed the pavers while also adding back new open graded stone and compacting it every 6 inches.

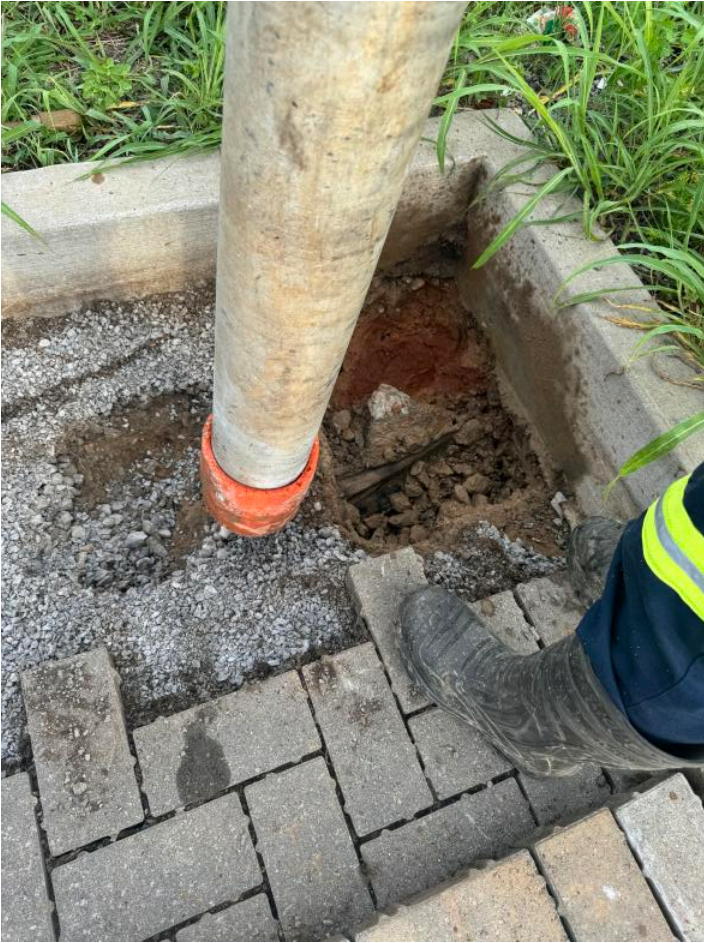
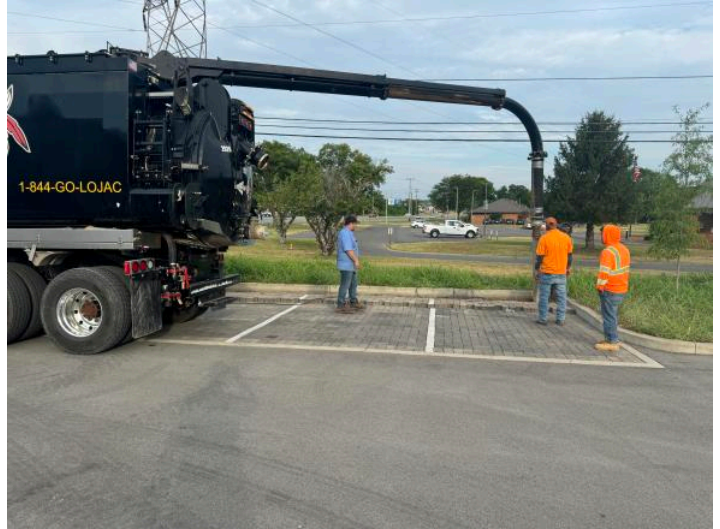
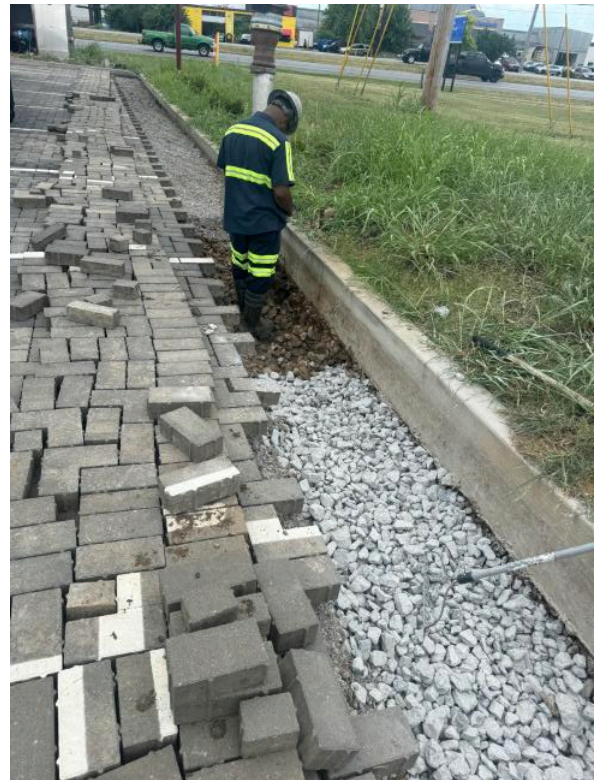
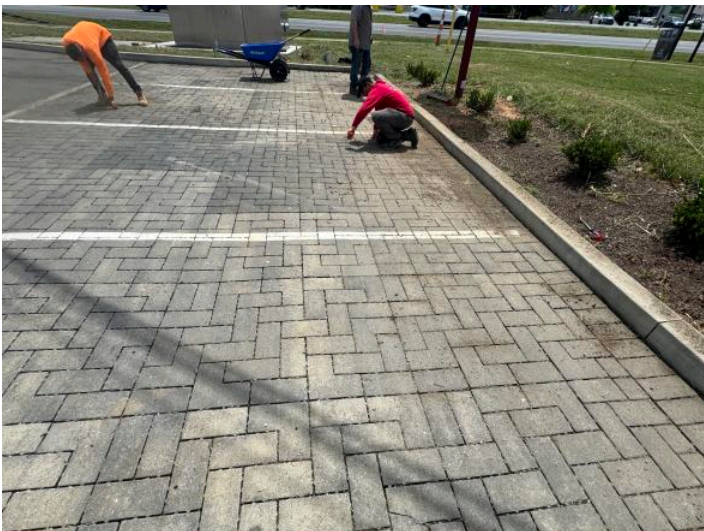
Pavers

During

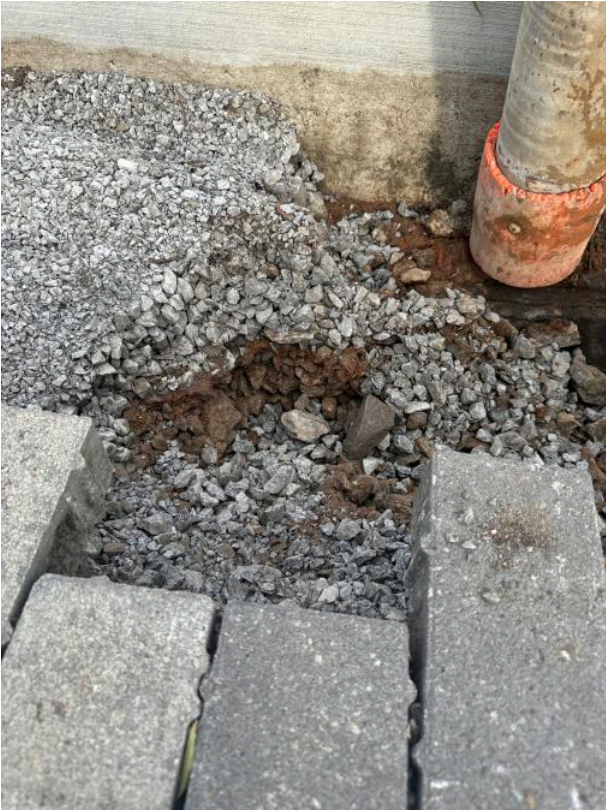
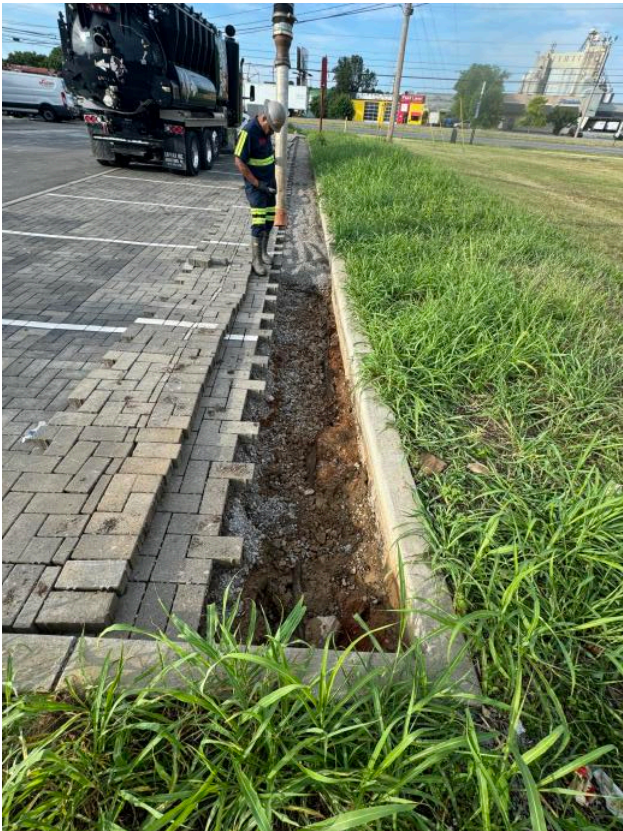
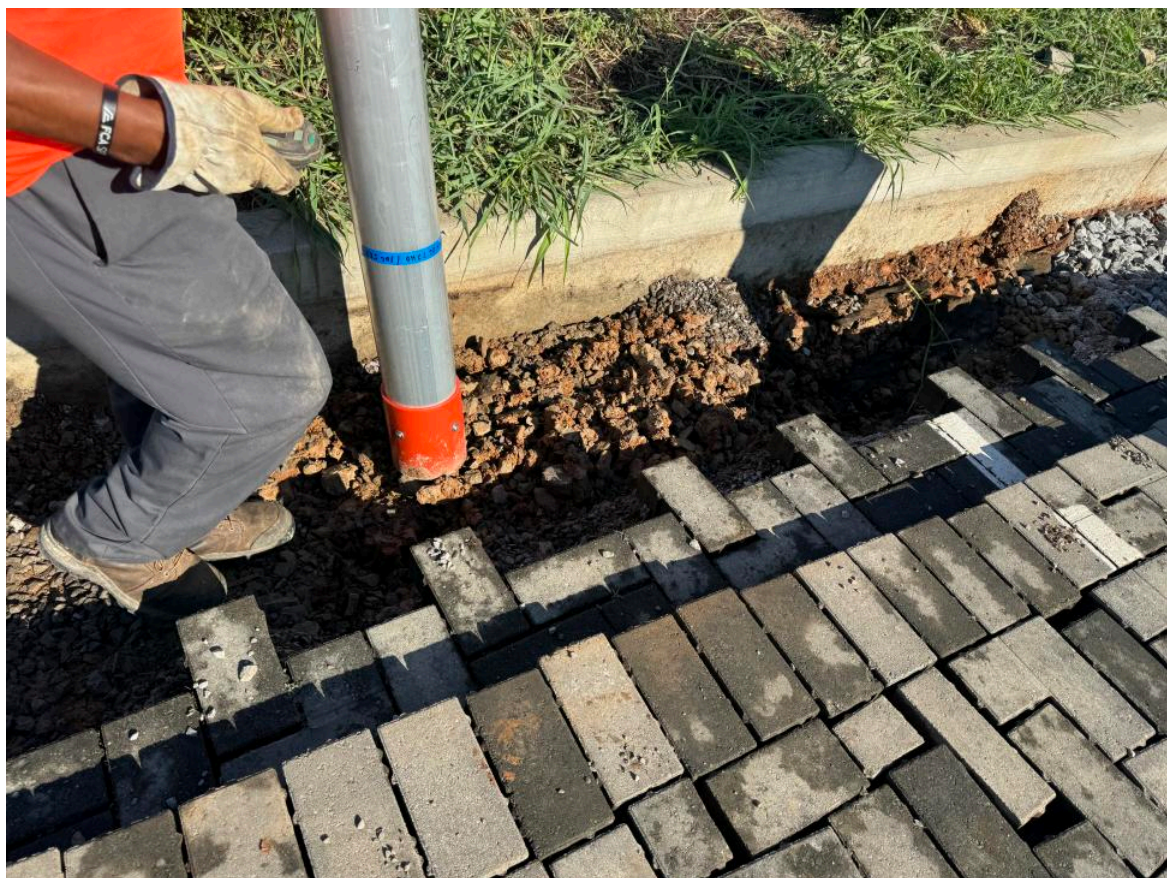
Pavers

During

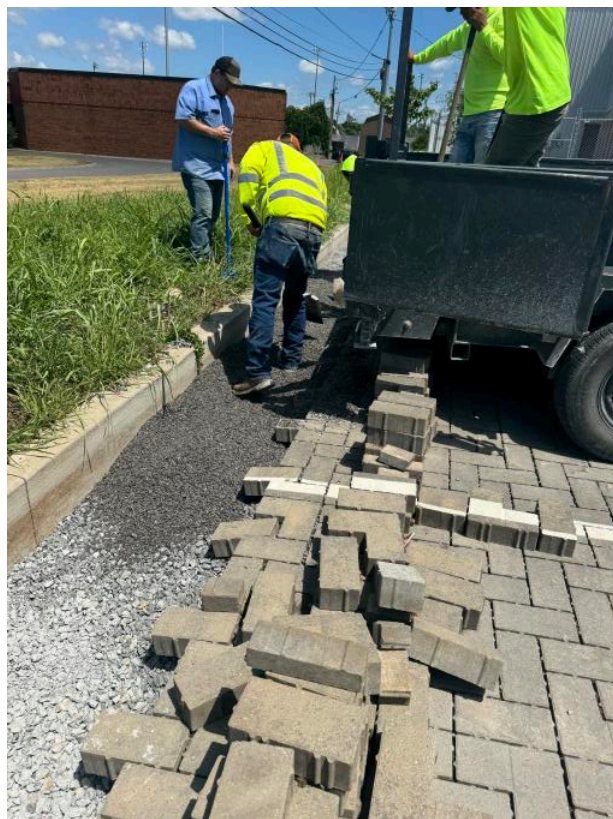
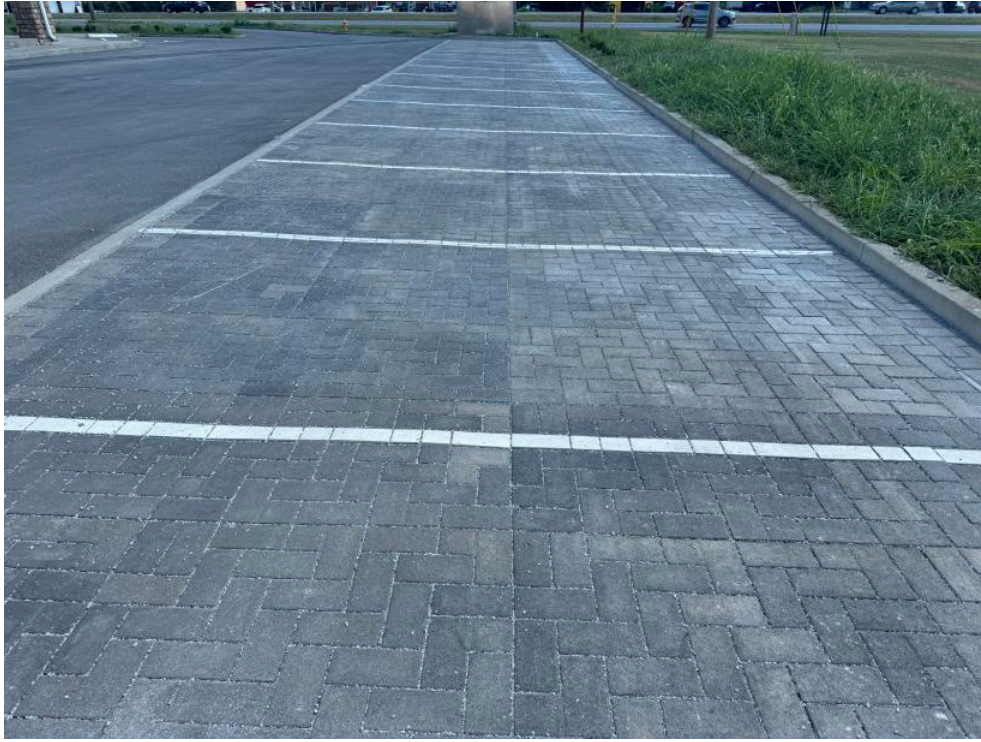
Pavers

During

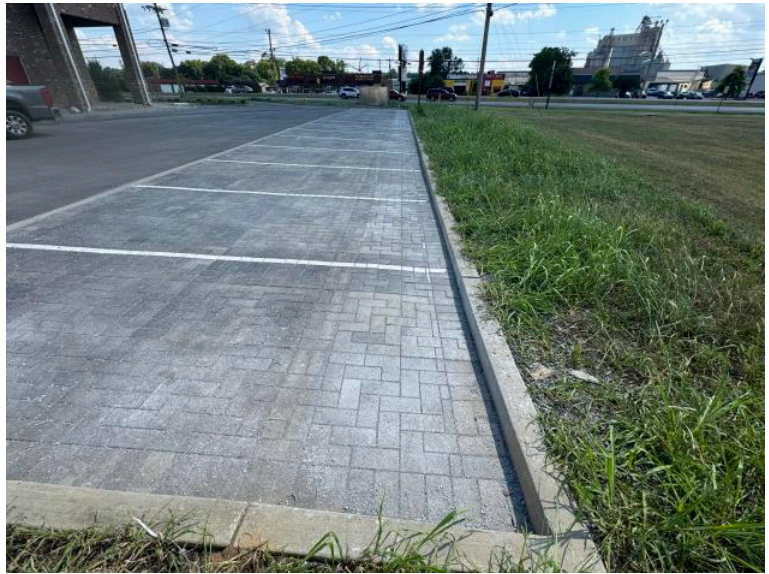
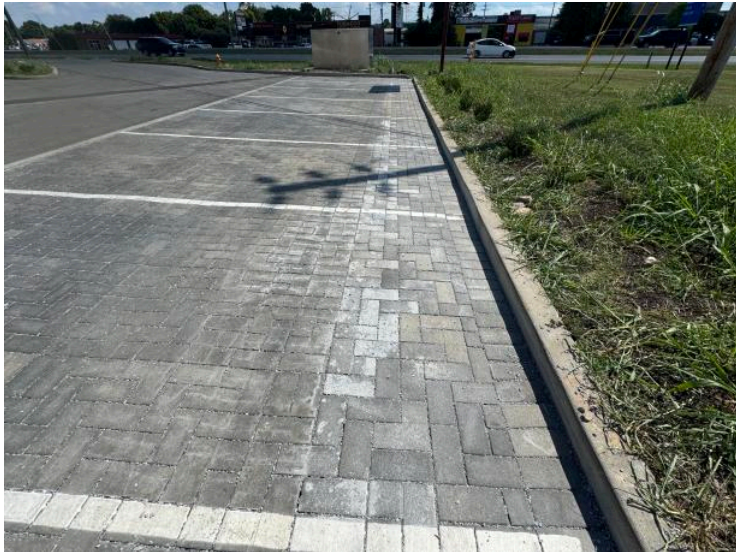
Pavers

After

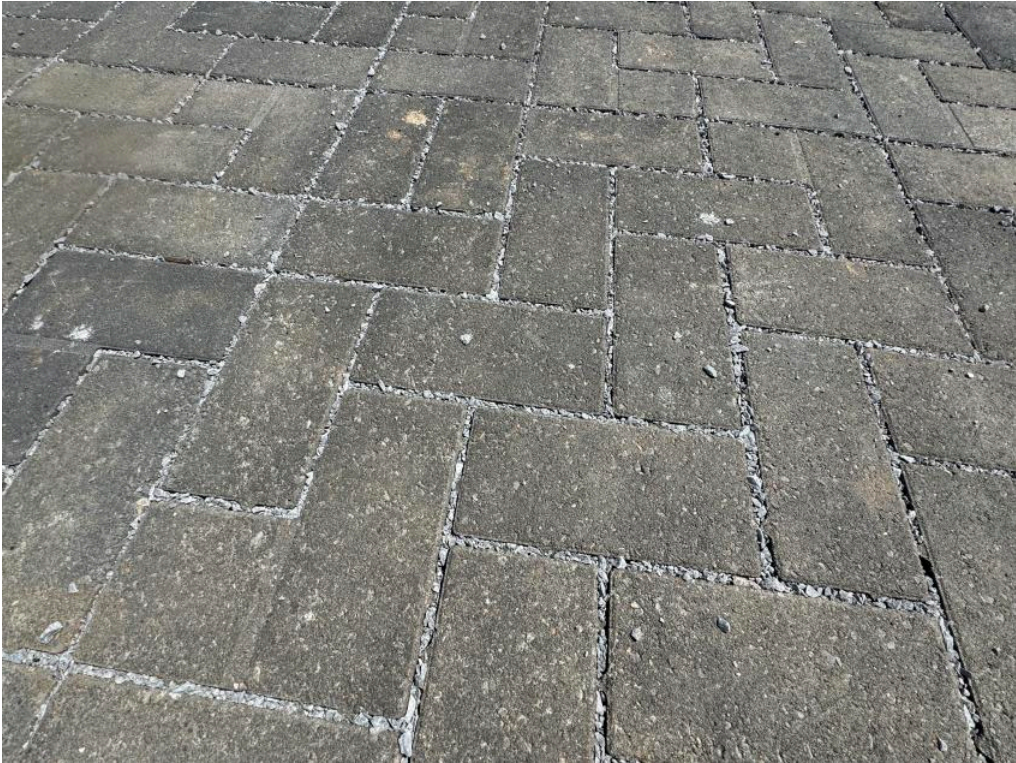
Pavers

After

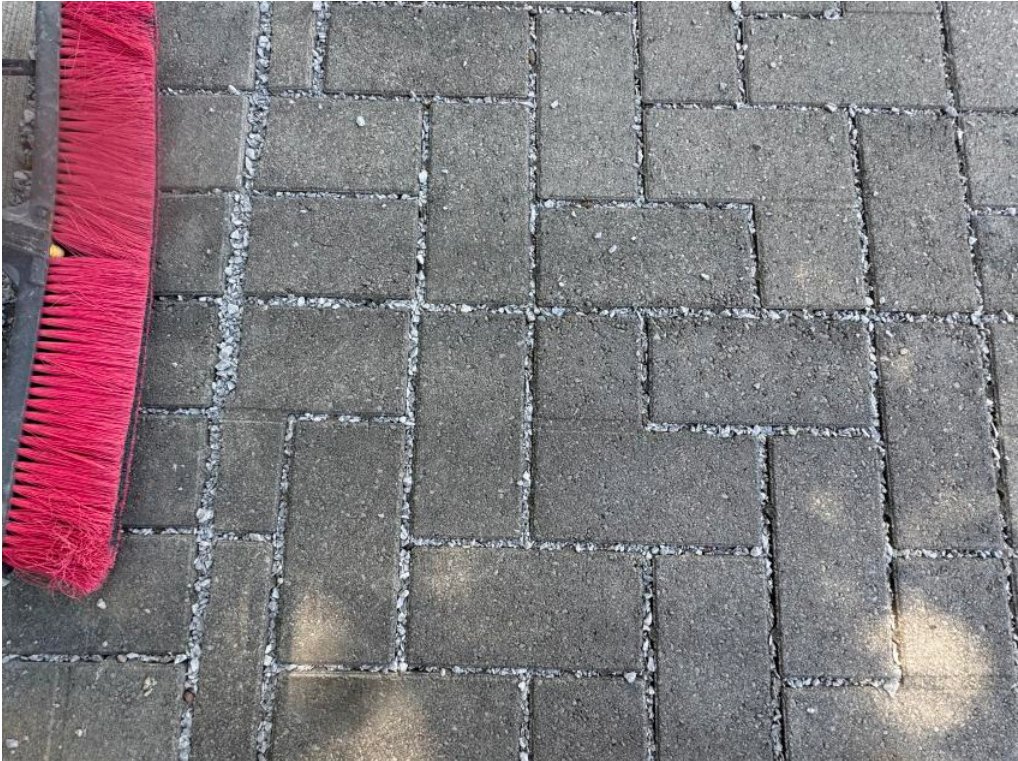
Pavers

After
