# STORMWATER MAINTENANCE REPORT

Facility: O'Reilly Automotive, Inc. - Store #6600      File No: GP#201100184

Location: 3847 Dickerson Pike, Nashville, TN 37207      Mailing Address: 233 S Patterson Ave, Springfield, MO

**MAINTENANCE PICTURES**

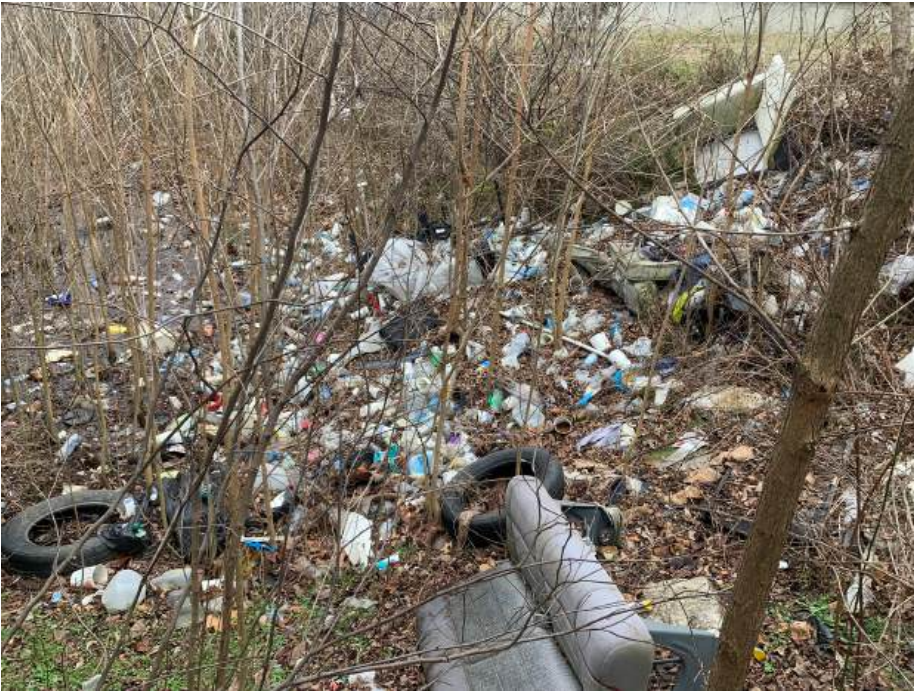
Before

Additional Notes:  
 EverGreen performed maintenance at O'Reilly Store #6600 on February 11th-13th. During maintenance the CDS2025-5 Water Quality Device had all contents removed via a vac truck and disposed of at an approved location. The system was fully maintained. The detention pond was found to be inhabited by unhousted individuals which resulted in tremendous amounts of trash. All trash and debris were removed from the pond and properly disposed of. Any invasive vegetation in the pond was also removed. The outlet control structure was uncovered and the pond was fully maintained.

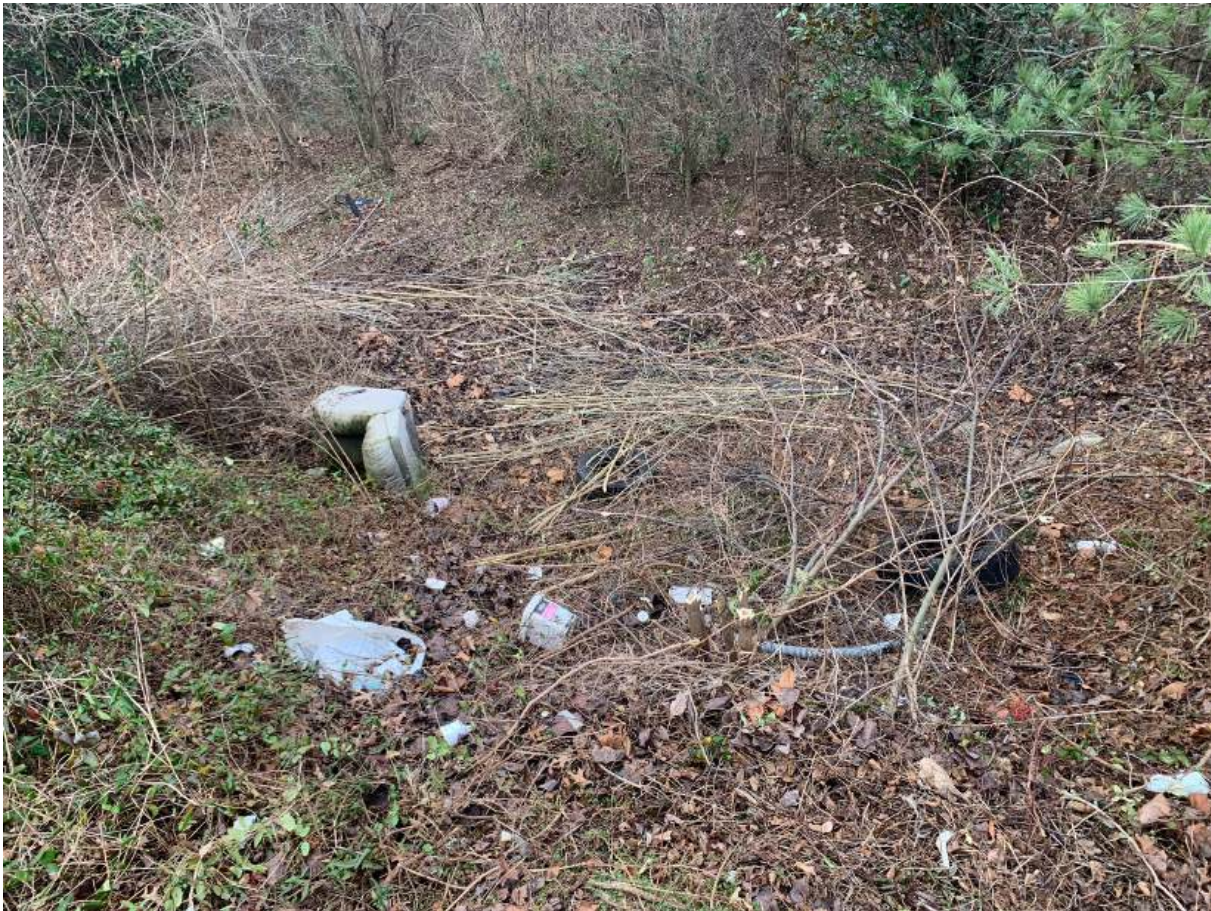
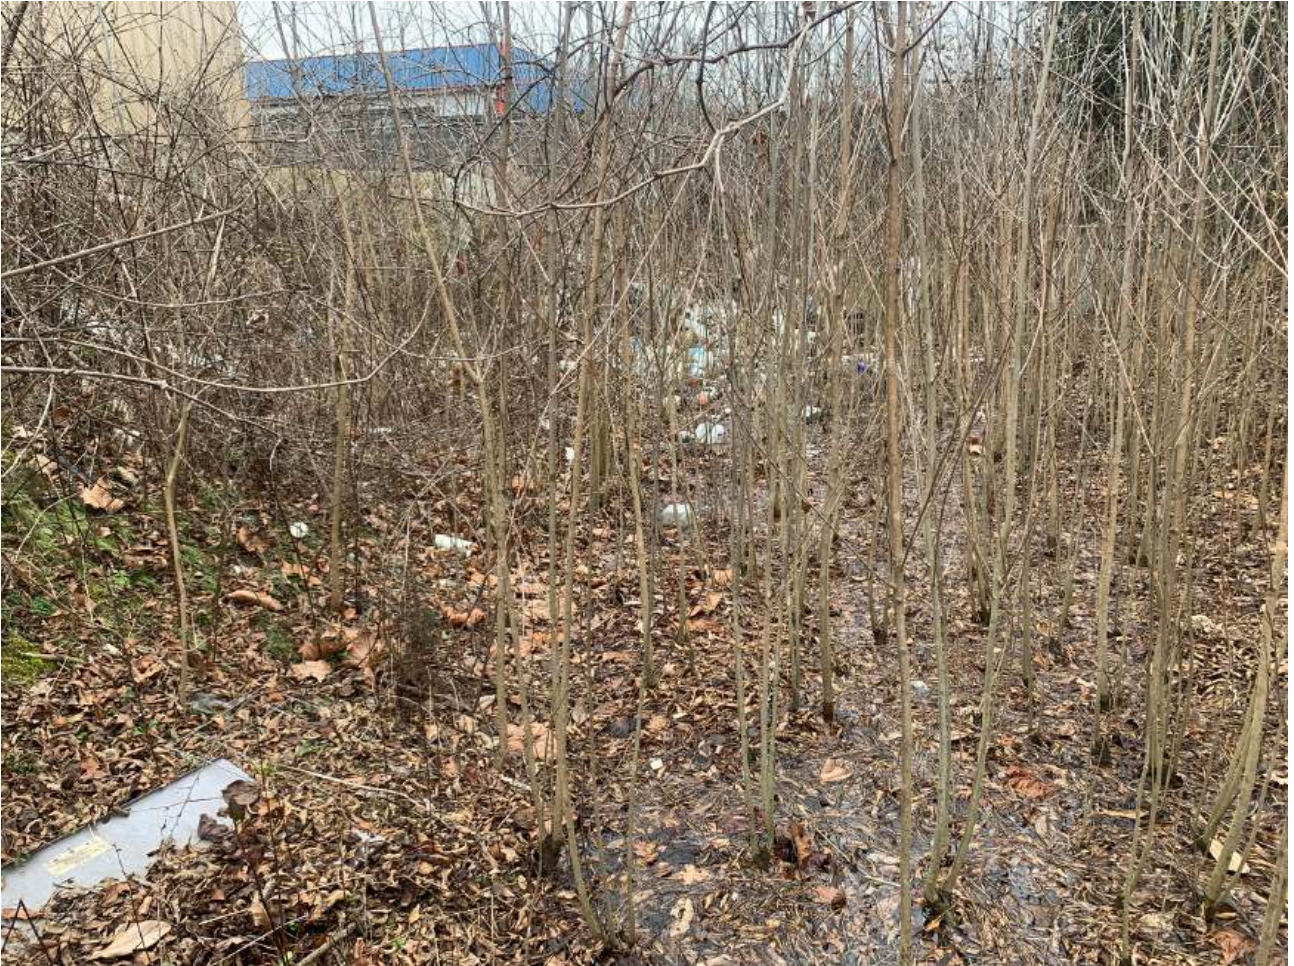
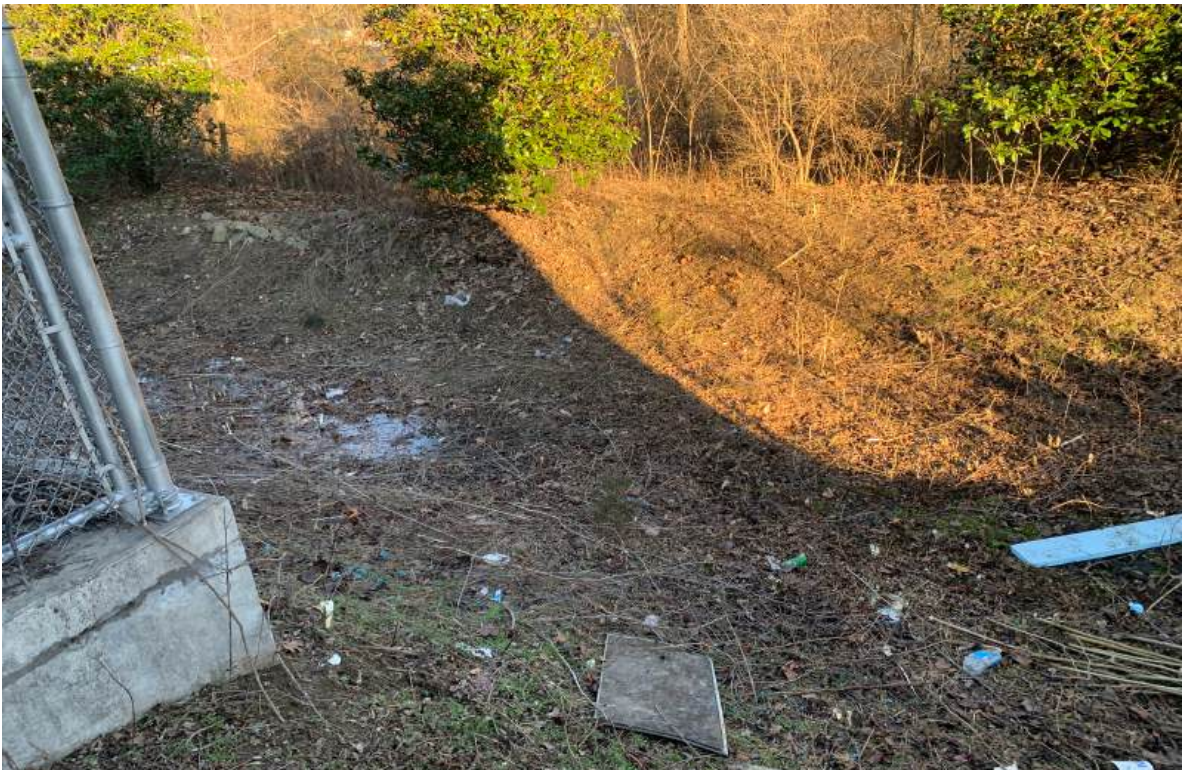
During

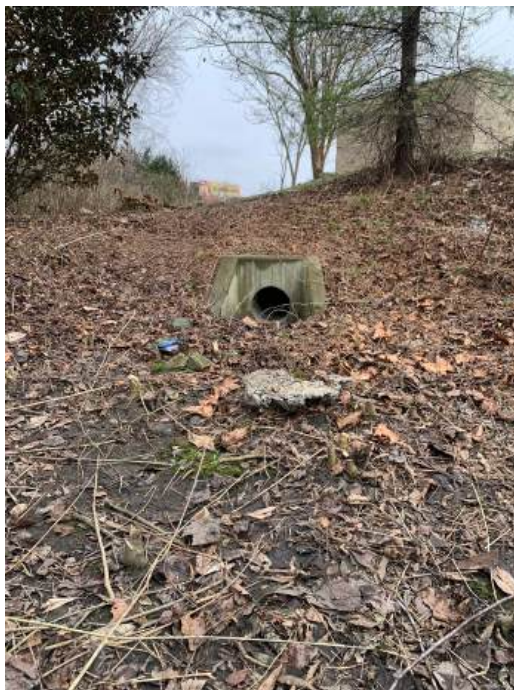
After

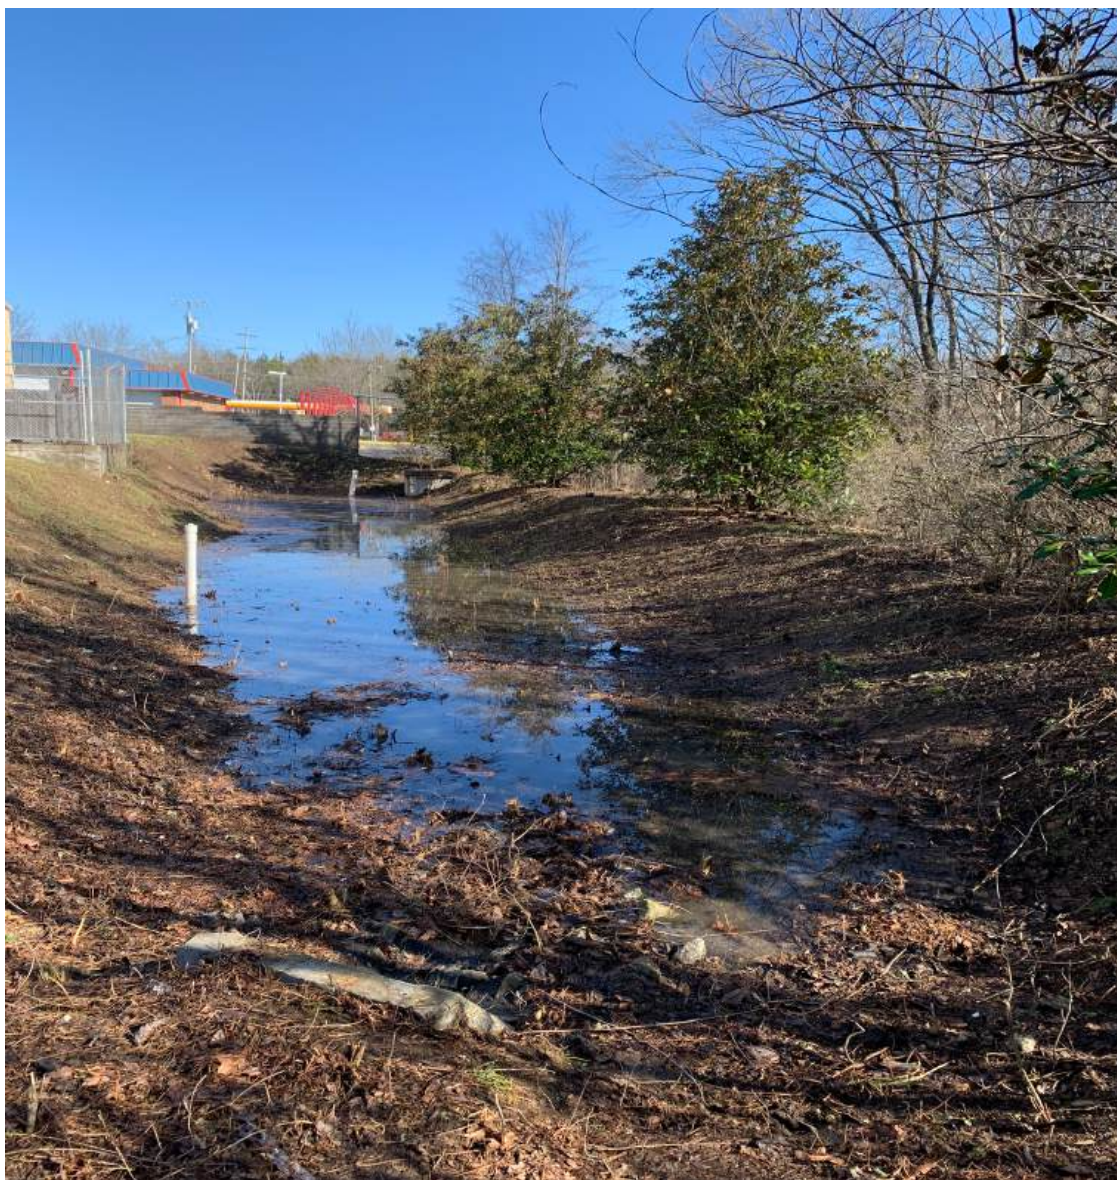
After

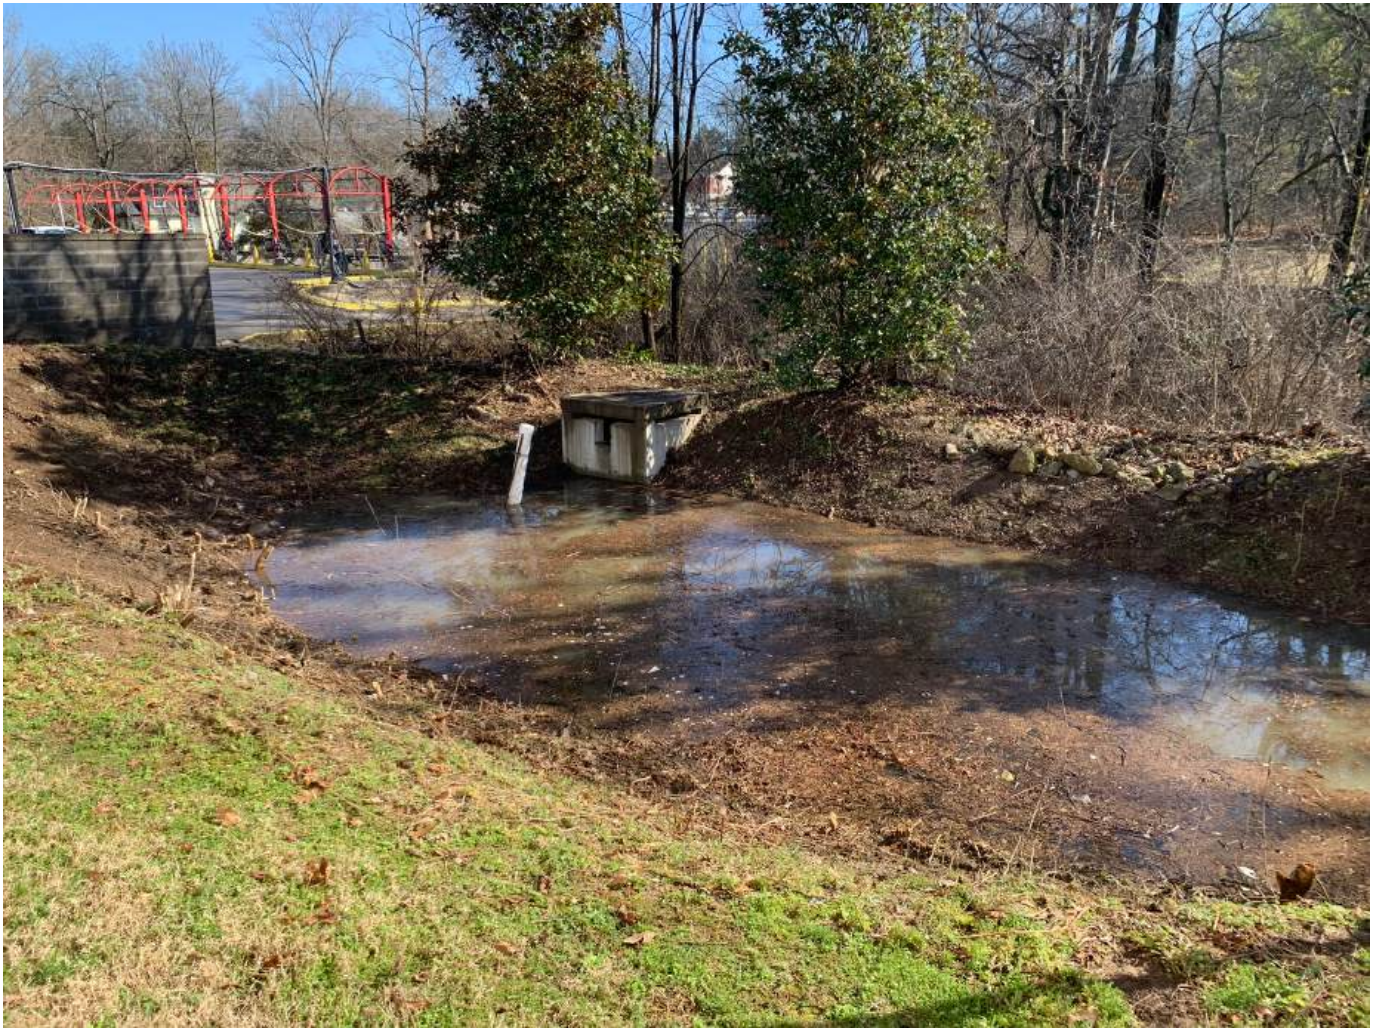
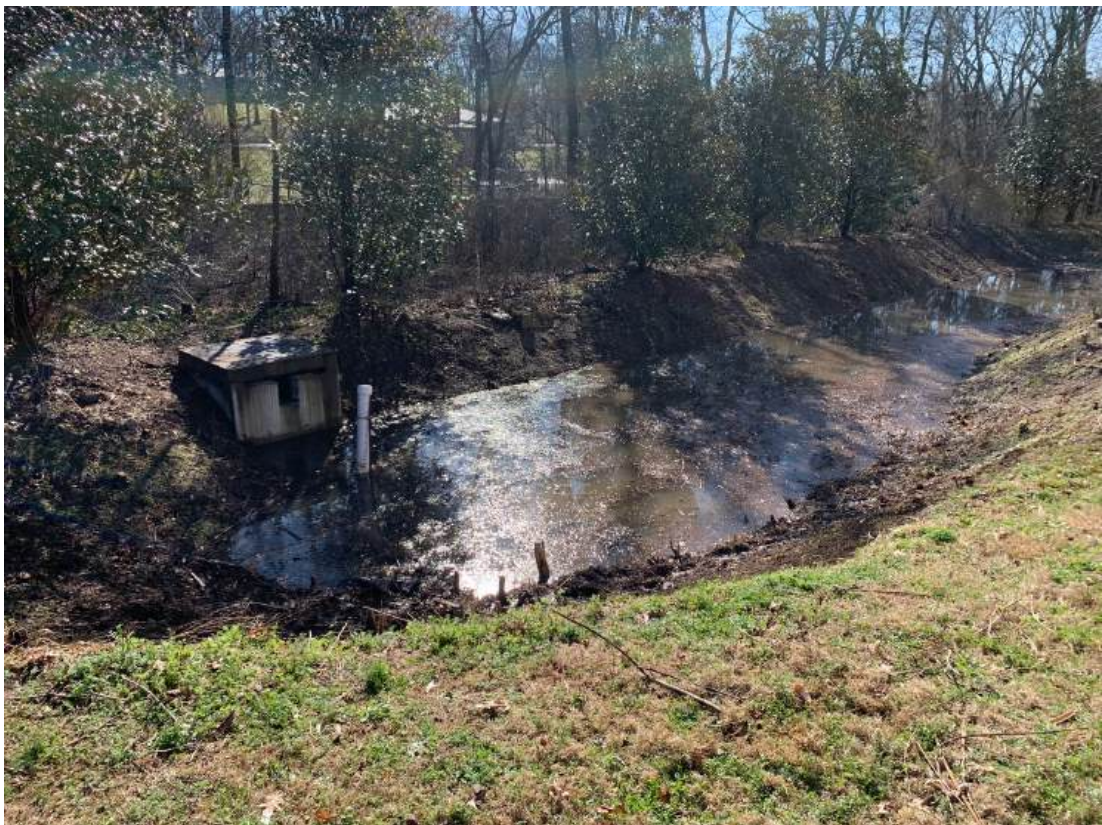
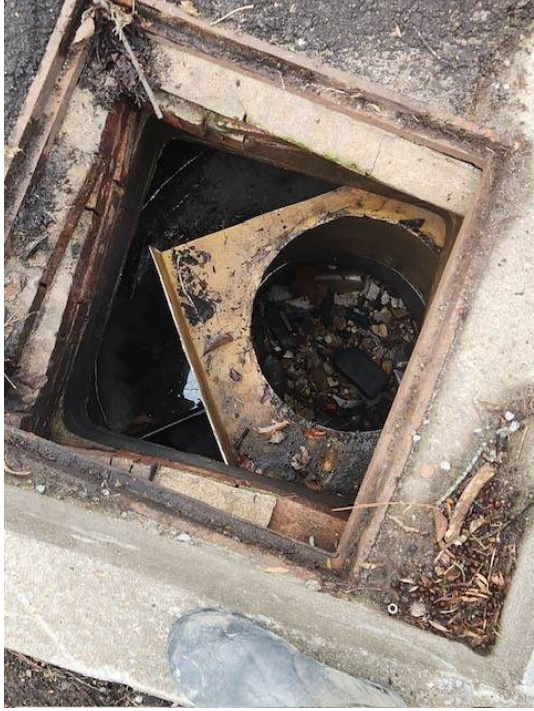
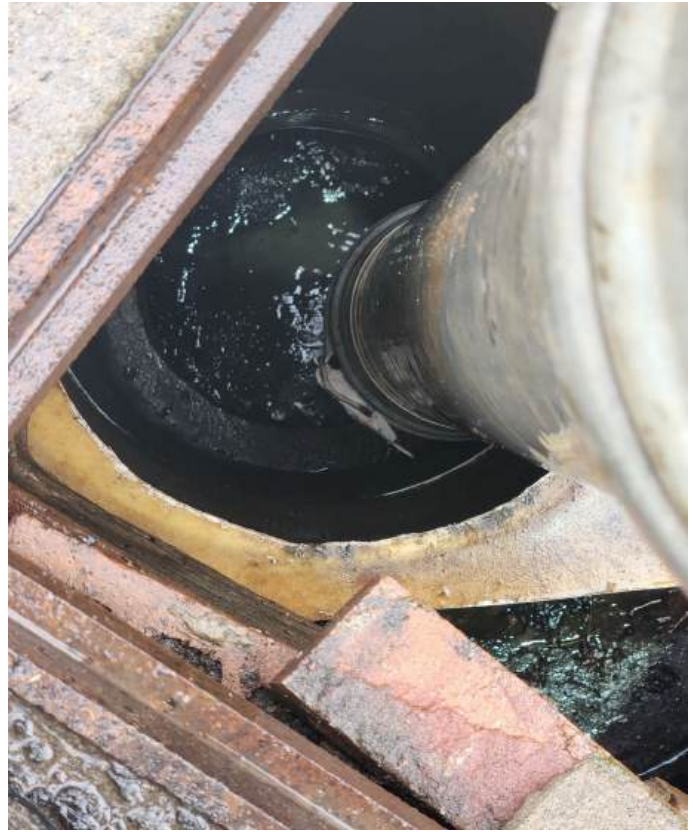
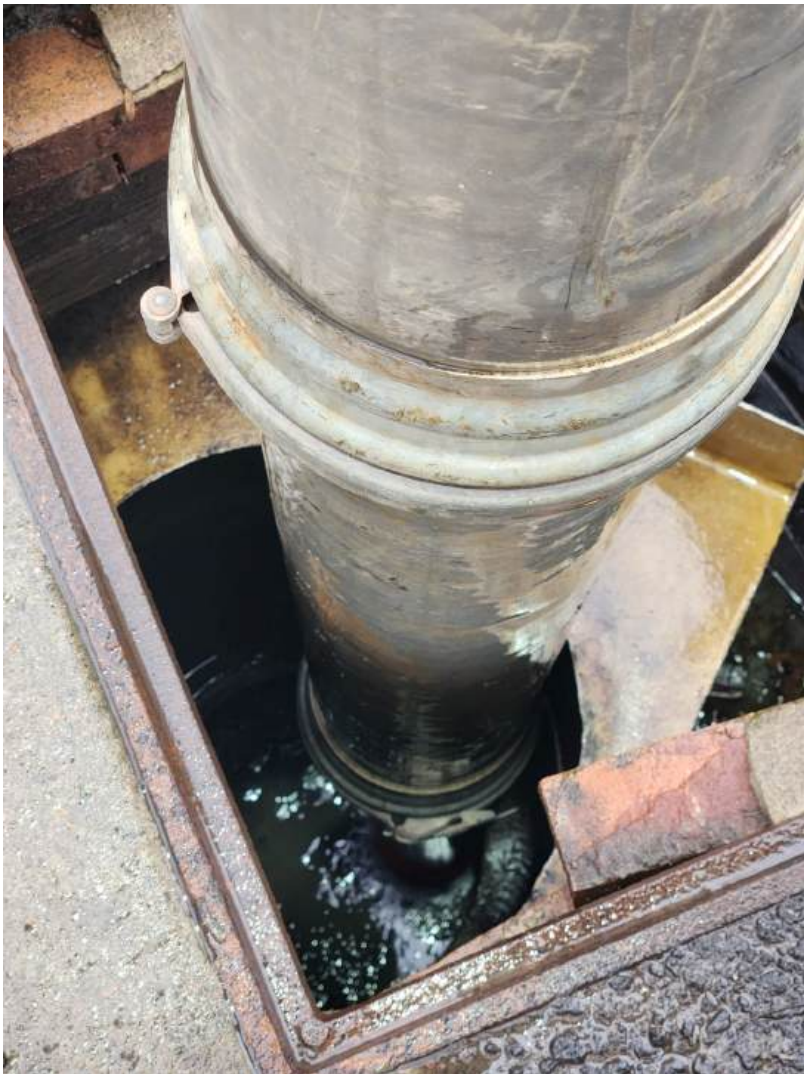
O'Reilly Auto Parts - Store #6600  
CDS2025-5 - Water Quality Unit  
Before & During Maintenance
