STORMWATER MAINTENANCE REPORT

Gallatin VA Clinic

Bioretention Pond

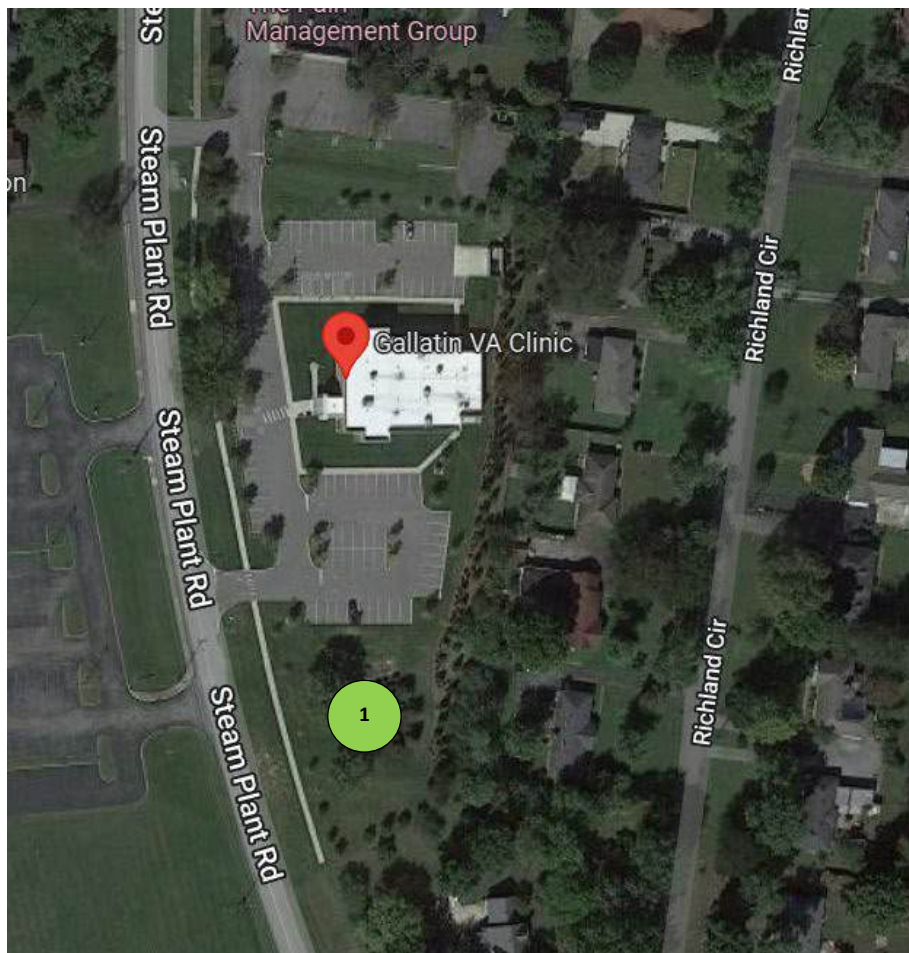
The green infrastructure practices that is employed on the site is one bioretention pond. The illustration below shows an overhead view of the facility with the bioretention labeled appropriately.

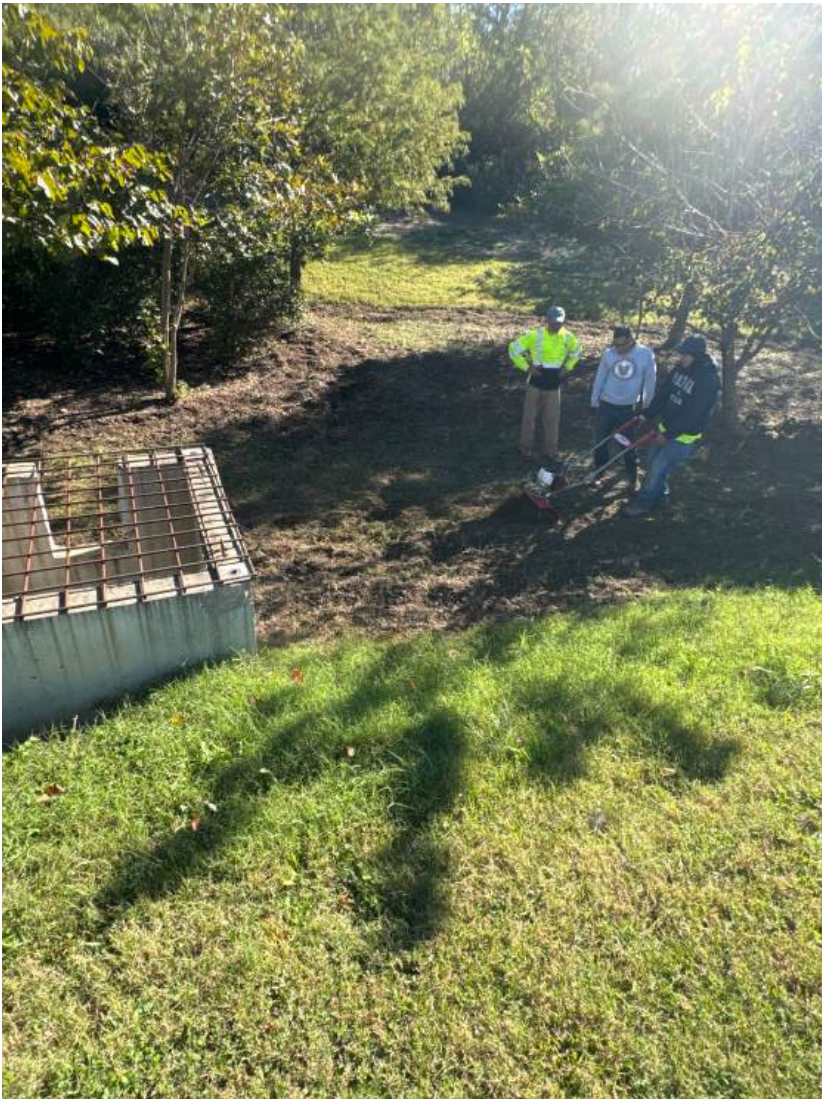
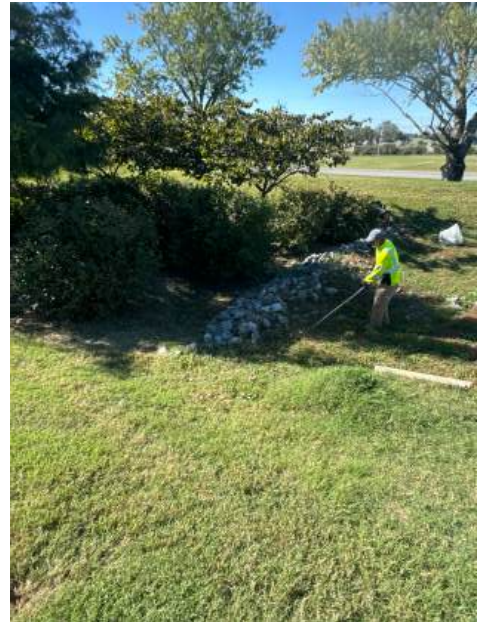
Before and During

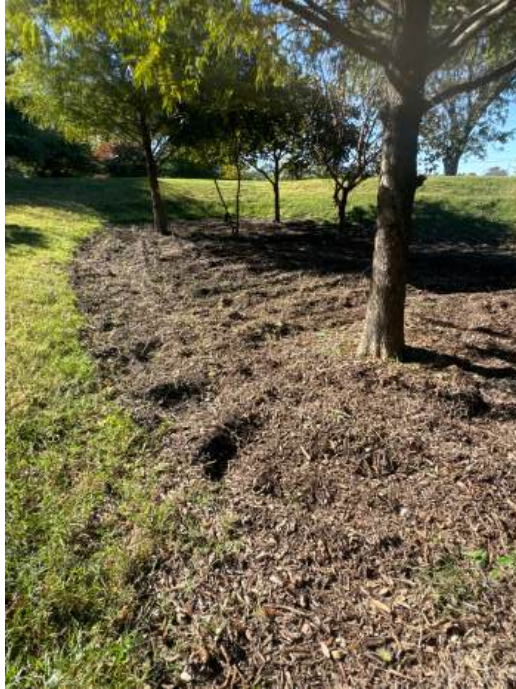
After
