# STORMWATER MAINTENANCE REPORT

5095 Murfreesboro Rd is a commercial construction site. The facility under construction by Sunbelt Construction company. The primary parcel that contains green infrastructure practices (GIP) is Parcel #015-002.12-000. The parcel contains 1.63 acres with a relative mix of pervious and impervious surfaces.

The green infrastructure practice that is employed on the site is permeable pavers. The illustration below shows an overhead view of the facility. The pavers that maintenance was done on are labeled appropriately.

**MAINTENANCE PICTURES**

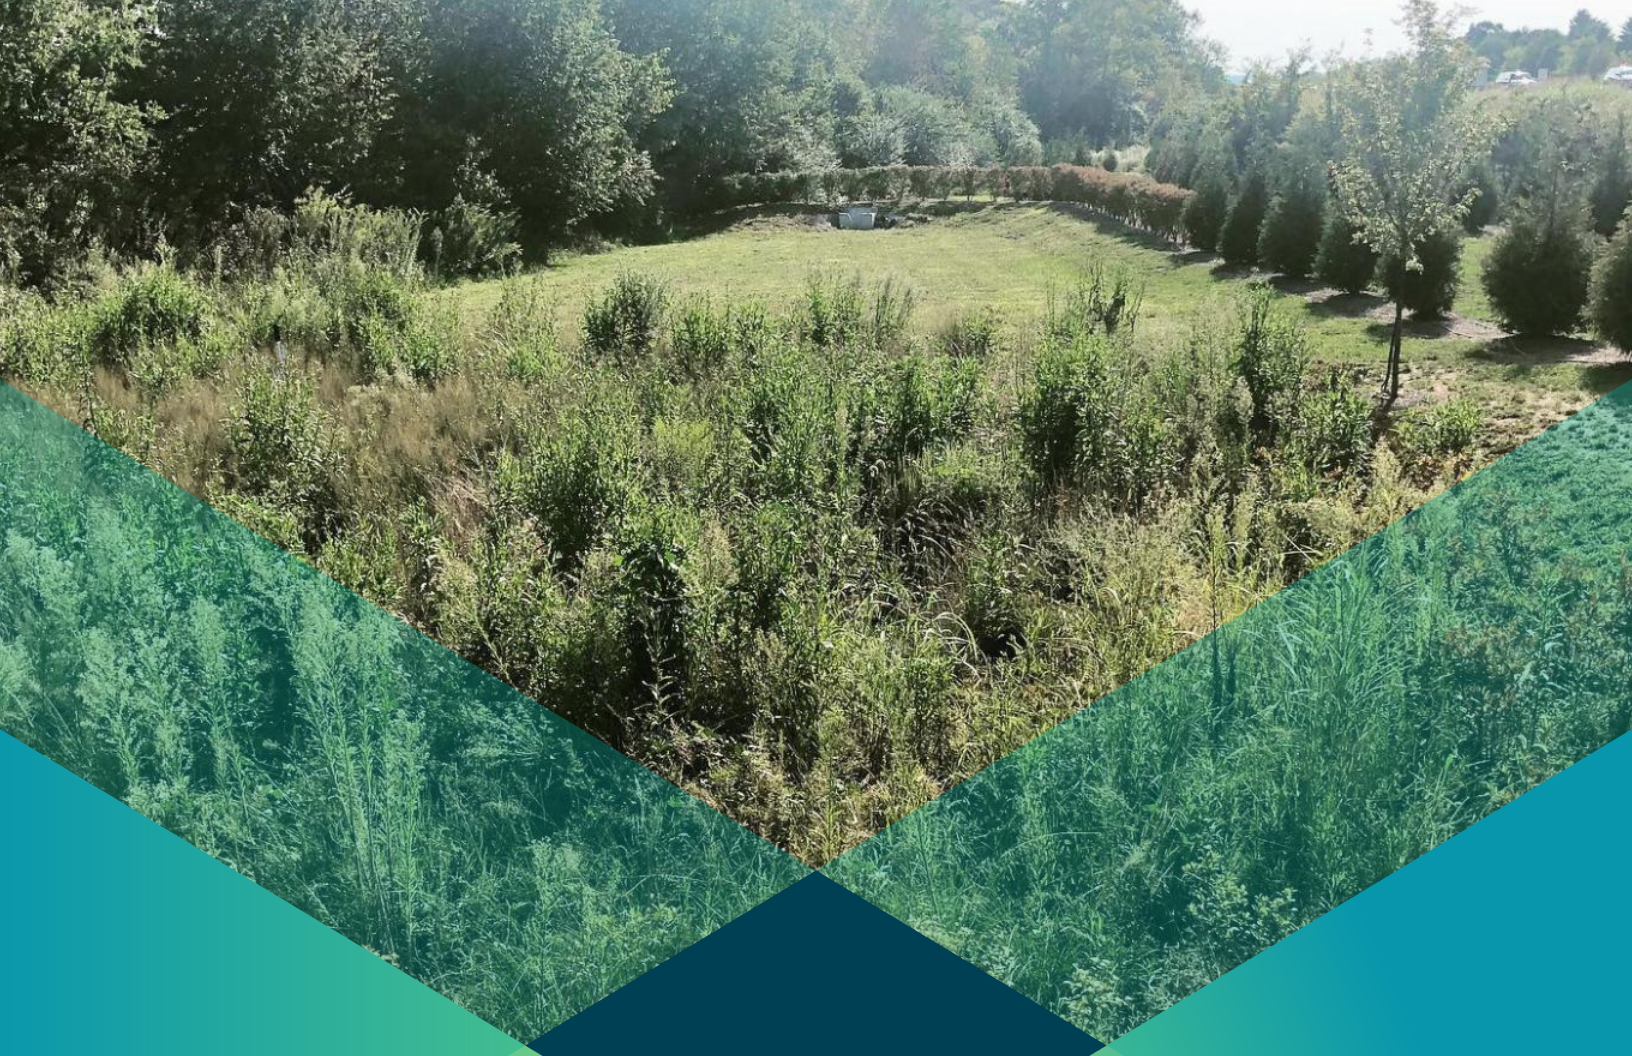
Additional Notes:  
 EverGreen performed maintenance at at 5095 Murfreesboro Rd. The location had three areas of permeable blocks that were not functioning correctly. EverGreen started by performing routine maintenance of the pavers such as using an air sweeper truck to remove debris. After further testing, it was determined that a the back 3 feet of the parking lot was so bad that a reconstruction in those areas was necessary. EverGreen removed the pavers in place, tested the layer underneath to determine infiltration, removed the open graded stone to a depth of 1.5 feet, and then reconstructed the pavers while also adding back new open graded stone and compacting it every 6 inches.
