# STORMWATER MAINTENANCE REPORT

Facility: O'Reilly Automotive, Inc. - Store #6600      File No: GP#201100184

Location: 3847 Dickerson Pike, Nashville, TN 37207      Mailing Address: 233 S Patterson Ave, Springfield, MO

**MAINTENANCE PICTURES**

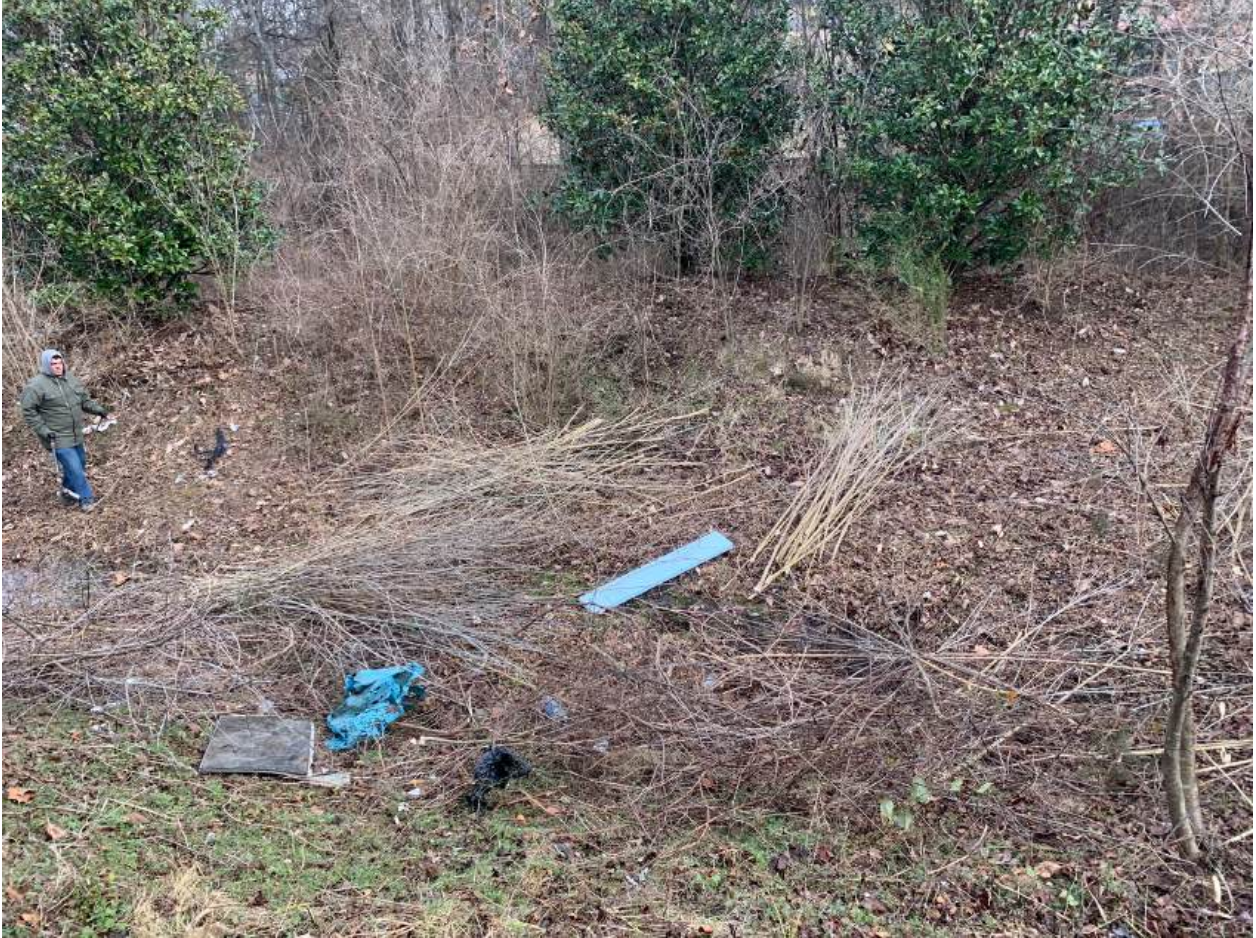
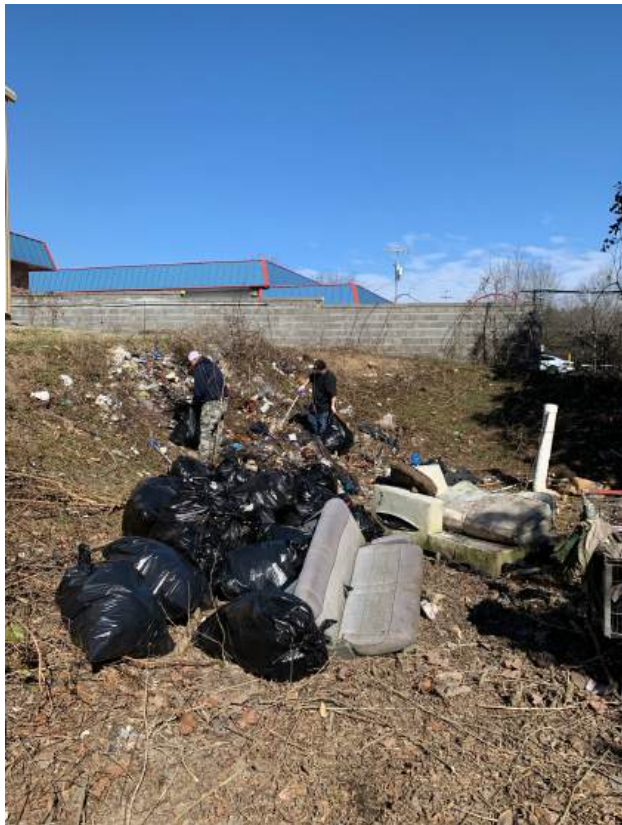
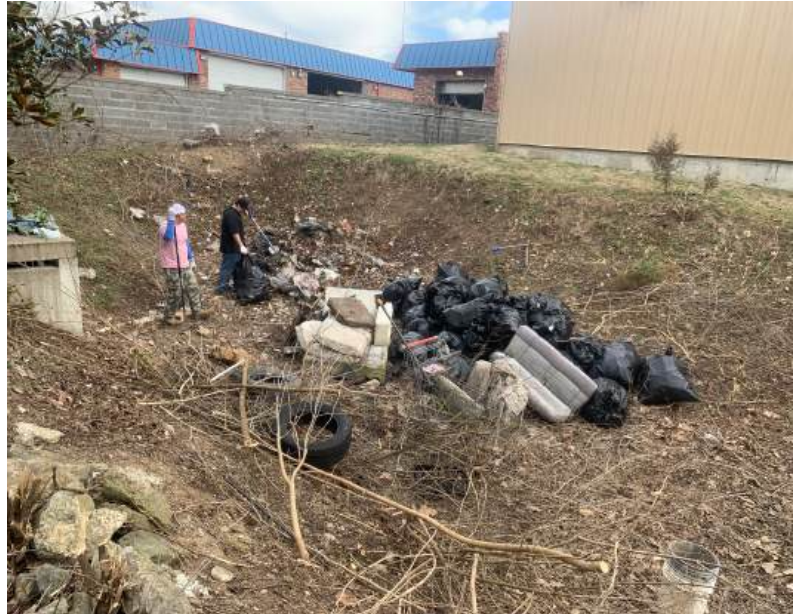
During

Additional Notes:  
 EverGreen performed maintenance at O'Reilly Store #6600 on February 11th-13th. During maintenance the CDS2025-5 Water Quality Device had all contents removed via a vac truck and disposed of at an approved location. The system was fully maintained. The detention pond was found to be inhabited by unhousted individuals which resulted in tremendous amounts of trash. All trash and debris were removed from the pond and properly disposed of. Any invasive vegetation in the pond was also removed. The outlet control structure was uncovered and the pond was fully maintained.
